3x Sample Property and Timber Pest Reports

Property and Timber Pest Report

Inspection Date: 6 Mar 2026

Property Address: 01 Sample st Armstrong Creek

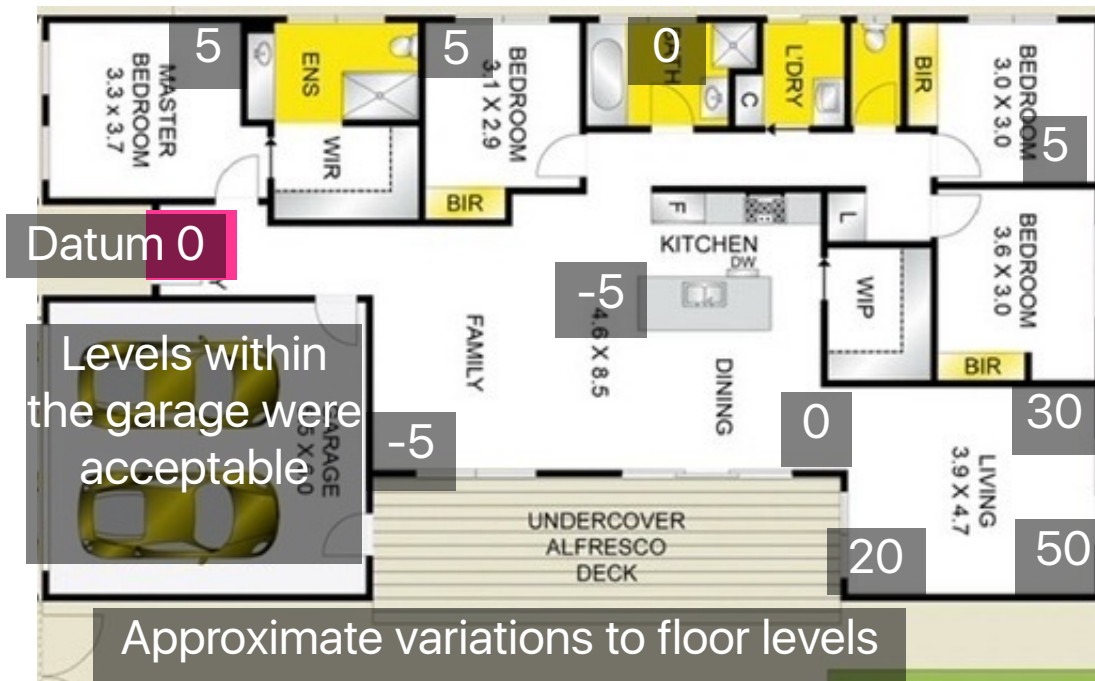
Major Defect 1.01

Finding: MAJOR STRUCTURAL DEFECT Slab Floor Levels

There was some variation to floor levels observed throughout the home. Approximately 55mm variation was observed over the footprint of the home. To give a comparison this is more than allowed as stated in Guide to Standards & Tolerances 2015 a publication produced by the Victorian Building Authority it states;

Except where documented otherwise, new floors are defective if within the first 24 months of handover they differ in level by more than 10 mm in any room or area, or more than 4 mm in any 2 m length. The overall deviation of floor level to the entire building footprint shall not exceed 20 mm.”

There was some minor cracking/movement to the brickwork observed. [See separate defect statement]

It would be prudent to have drainage pipes checked with a camera to ensure there is not a underlying issue. [leaking pipes]

An investigation (by a competent person e.g. a structural engineer or underpinning specialist) is recommended as soon as possible to determine the method and extent of any remedial work required and associated costs.

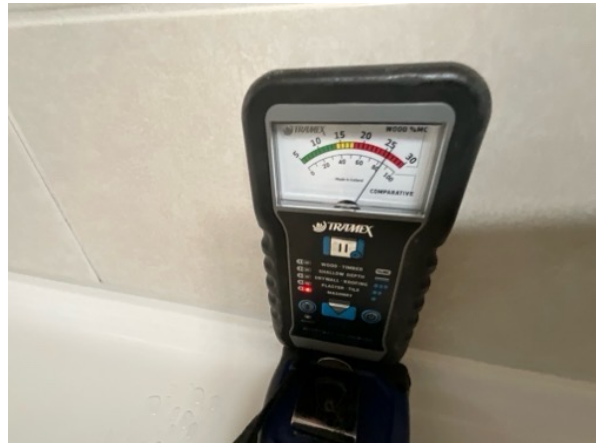
Minor Defect 2.01

The ensuite shower enclosure failed a moisture meter test which indicated moisture behind the lower wall tiles. Showers do require ongoing maintenance as grout can deteriorate over time often resulting in cracking and or pinholes to the finish of it reducing its capacity to effectively seal. Silicon should be used to seal all corner joints of tiling and where it meets baths, shower bases etc. Silicone sealants do have a limited lifespan and industry recommendations suggest it may require replacement after five years. Leaking showers can cause significant damage if left unrepaired. An investigation (by a competent person e.g. a bathroom specialist) is recommended as soon as possible to determine the method and extent of any remedial work required and associated costs.

Note: There was no evidence observed of the moisture escaping from the confines of the waterproof membrane that should have been installed.

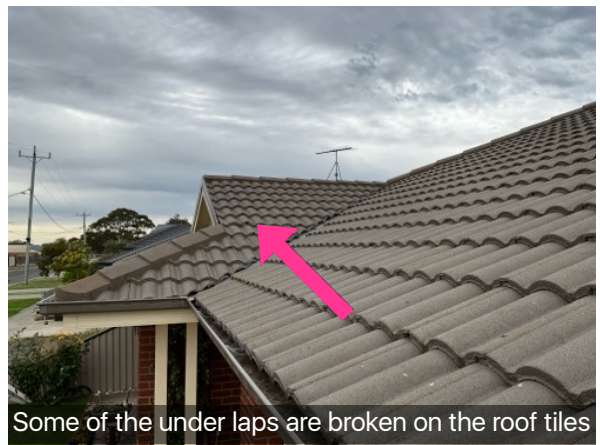
Minor Defect 2.02

Finding: Broken Roof Tiles

There were some broken and chipped tiles observed that need to be replaced. (See photos attached) These tiles if not replaced can result in the ingress of moisture into the building which can cause deterioration to internal elements of the property. A further detailed investigation (by a competent person eg. a licensed roof tiler) is recommended as soon as possible to determine the method and extent of any remedial work required and associated costs.

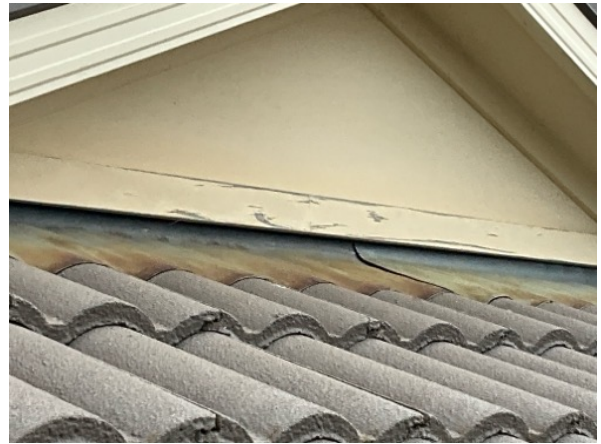
Minor Defect 2.04

Finding: Minor Defects

During the inspection of the property, it was noted that there are some minor defects present throughout the premises. The typical imperfections observed will often include cracks, surface rust, dents, and scratches in the plaster surfaces, fixtures, and fittings that are consistent with a home of this age. While these defects may be considered minor, it is important to note that they can still affect the overall condition and value of the property. The attached photos provide a visual representation of some of the defects observed, but this should not be taken as an exhaustive list. It is highly recommended that a qualified tradesperson be engaged to assess and rectify any defects that are not purely cosmetic in nature, in order to ensure the continued liveability of the home.

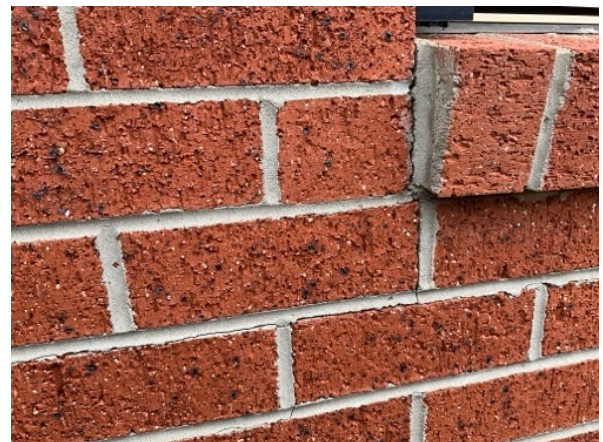
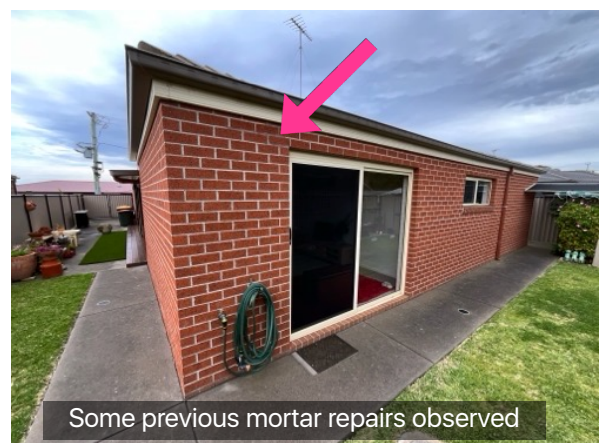
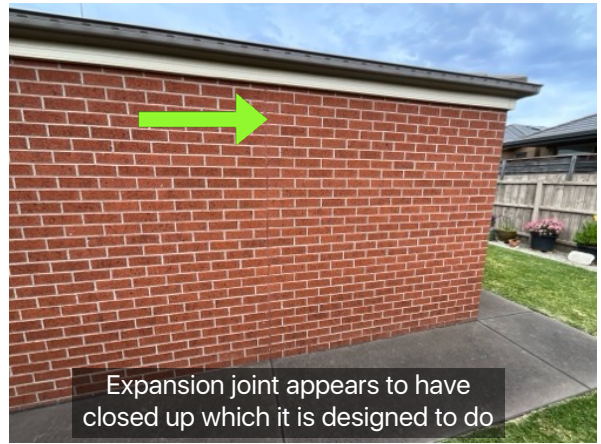
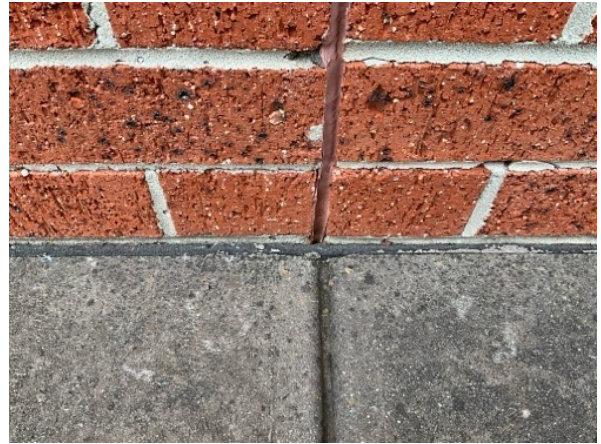
Minor Defect 2.05

Finding: Cracking in brickwork

Some minor cracks and movement less than 3mm in width were observed in the brickwork around the home. This would be graded as a category 2 crack by the below table. Recommend to monitor crack and if it increases in width to get a more detailed investigation by a competent person, (e.g. a licensed building contractor) to determine the method and extent of any remedial work required and associated costs.

Category 2 cracks to walls are to be monitored for a period of 12 months. At the end of the monitoring period, a crack rated at Category 2 or above is defective and requires rectification. Category 2 damage is defective and requires minor repair work such as repointing.

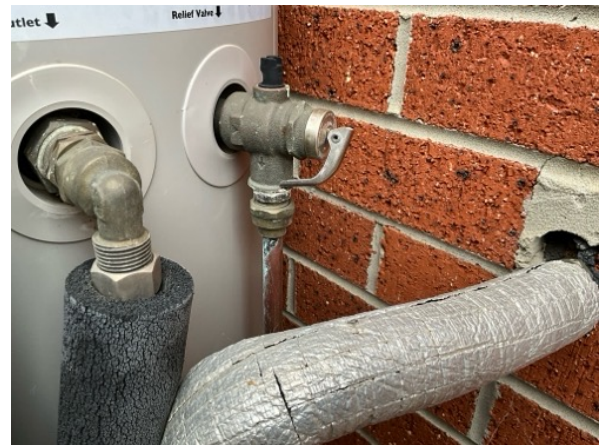
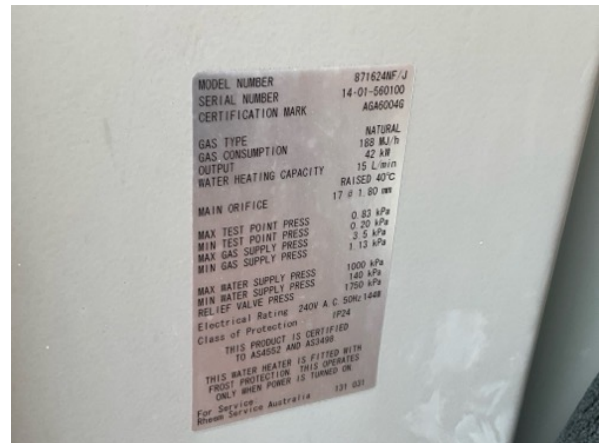
Minor Defect 2.07

The only way to check the operation of the solar heating panel is to check on the temperature of the water in the storage tank. This can be done at the unit using the pressure relief valve. When checked this water was cold indicating that the solar water heating system may not be working. There is still an instant gas hot water service that is supplying hot water to the home this is still operational. An investigation (by a competent person e.g. a licensed plumbing contractor) is recommended to determine the method and extent of any remedial work required and associated costs.

Note: It may be possible to replace the solar unit, however in the past they have not had a great service life. Recommend to chat with a plumber to see if the cost to replace justifies the expense.

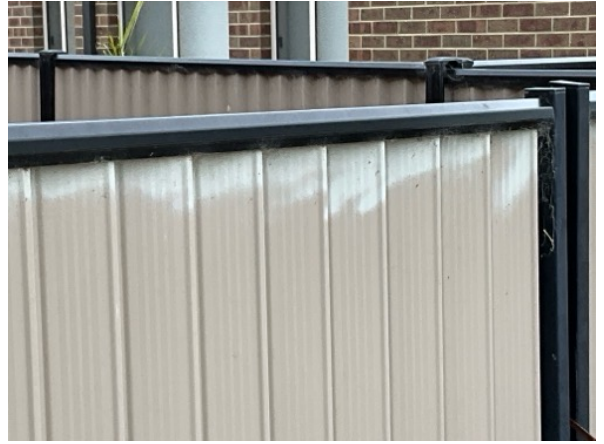
Minor Defect 2.08

The paint on the colorbond steel is faded [See photos attached for details] This fading is due to it being spray painted with a touch up can and over time it has weathered differently and now stands out. It may be possible to carefully remove the spray paint using a rubber eraser and have the original paint surface below. An investigation (by a competent person e.g. a handyman) is recommended to determine the method and extent of any remedial work required and associated costs.

BlueScope does not recommend the use of touch-up paint to repair damage or scratches to the painted surface. As explained above, air-drying paints have different weathering characteristics to COLORBOND® steel, which leads to variations in appearance over time where touch-up paint has been used. BlueScope does not have a recommended method for the removal of touch-up paint. Minor scratches (< 2mm in width) should be left alone as the available metallic coating will continue to protect against corrosion providing the scratches are superficial and the metallic coating is not damaged. If scratches are more noticeable on new material, it is the recommendation of BlueScope to replace the affected product.

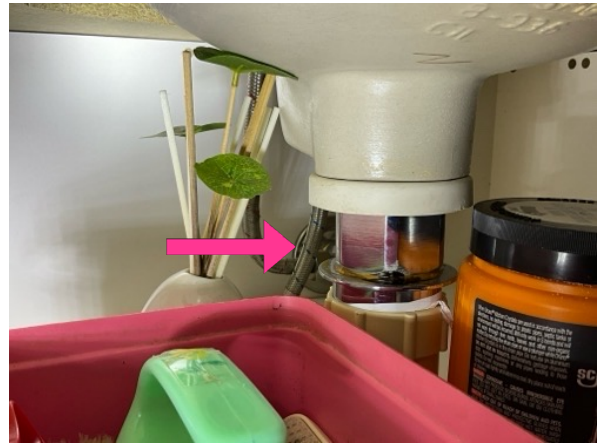
Flexible hoses do require regular checking to ensure they are in good order. There was no corrosion observed with the flexible hoses at the time of the inspection however these are out of sight and out of mind and have been described as a ticking time bomb. See extract from a article below.

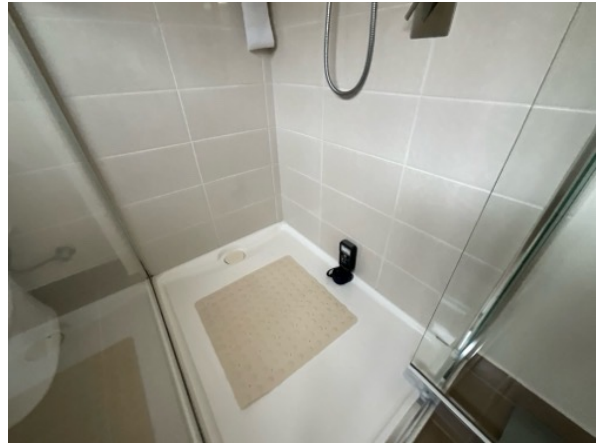
There was detected high levels of moisture behind the wall tiles in the shower (see photos attached) this is indicative of moisture ingress past the outer layer of the enclosure. [See separate defect statement in building report] Excessive moisture is always concerning as it results in conditions conducive towards timber pest activity. [fungal decay, termites etc] An investigation (by a competent person e.g. a bathroom specialist) is recommended to determine the method and extent of any remedial work required and associated costs.

Note: Where there has been installed a waterproof membrane behind the tiles this moisture may have been prevented from affecting the internal elements of the building. This cannot be verified without a more invasive investigation.

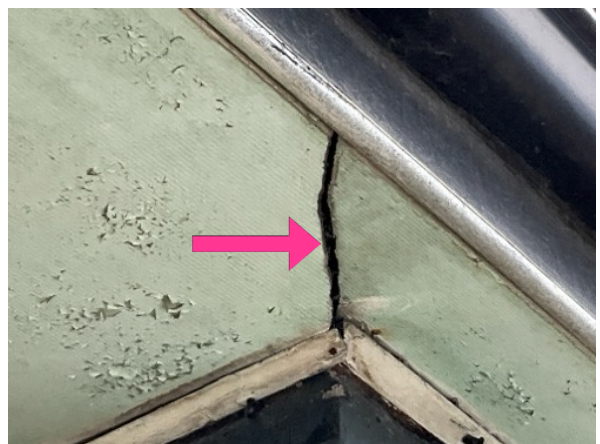
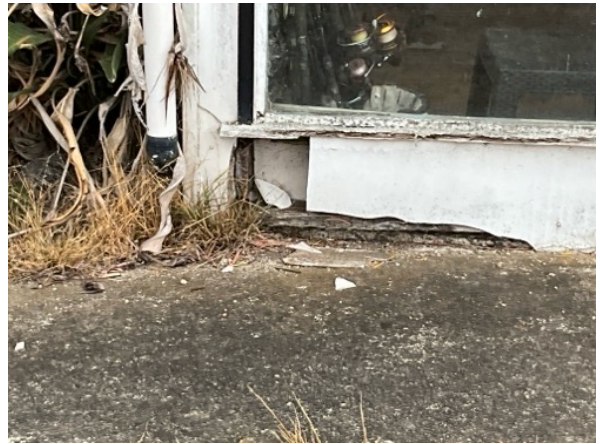
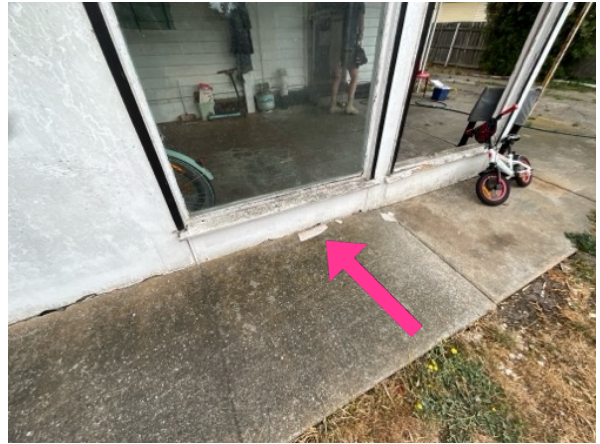
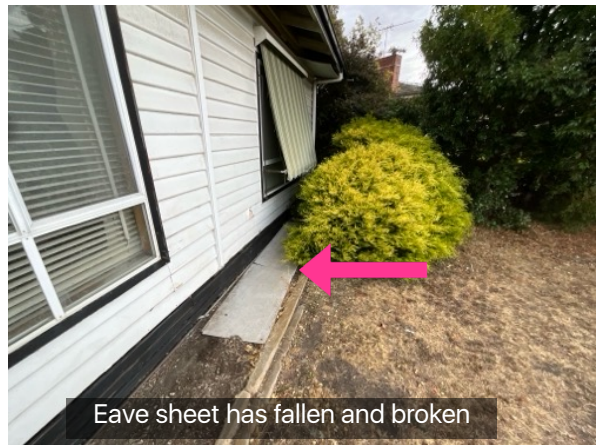
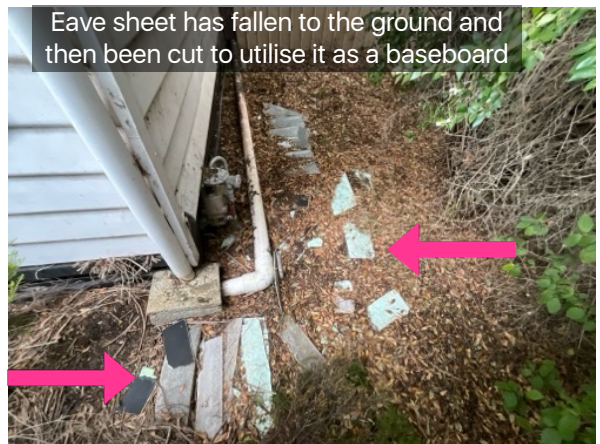
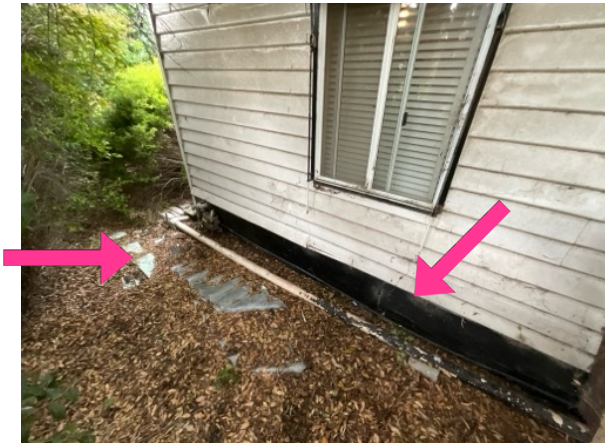
Finding: Asbestos?

The property presents a significant safety concern due to compromised cement sheeting, likely containing asbestos fibers. Examination reveals numerous sheets throughout the property that are cracked or broken, with several instances of eave sheets having detached from the fascia and fallen to the ground. Disturbingly, some of these fallen sheets have been repurposed as baseboards, increasing the risk of exposure to potentially harmful asbestos fibers. Furthermore, it is most likely that there are loose fibers on the ground where asbestos sheeting has been cut, posing an inhalation risk. Many of the eave sheets are not securely fastened, heightening the danger of further detachment. Overall this situation constitutes a severe hazard, and it is strongly recommended that the property remain unoccupied until a comprehensive inspection and analysis are conducted by an asbestos specialist. Immediate remedial action is advised to mitigate any health risks. It is crucial to engage a licensed professional to assess the extent of asbestos presence and execute safe removal and disposal of affected materials. Additionally, reinforcing or replacing the unsecured sheeting should be carried out to prevent future incidents. Implementing these measures is essential to ensure the safety and integrity of the property before habitation can be considered.

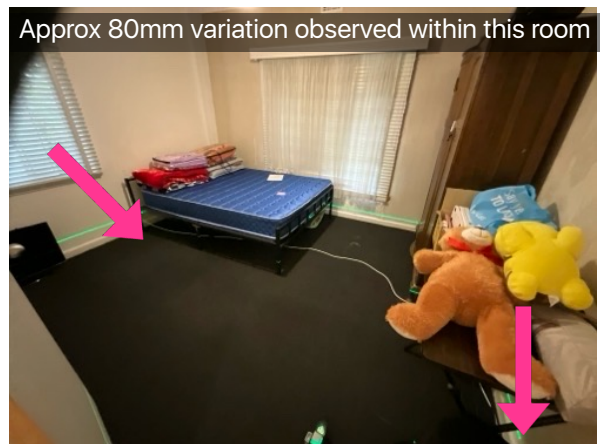
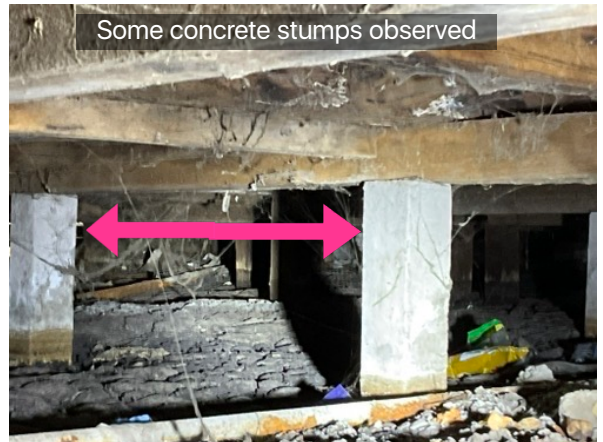
Major Defect 2.01

Note: Some of the house is low to the ground when restumping it would probably entail lifting internal floorboards to access the stumps.

A further detailed investigation (by a competent person e.g. a licensed engineer/underpinning contractor) is recommended to determine the method and extent of any remedial work required and associated costs.

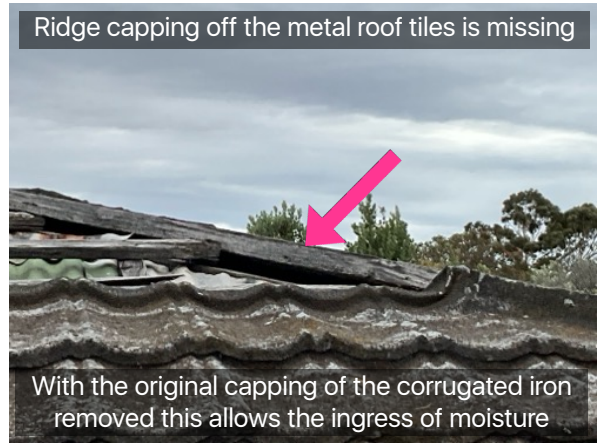
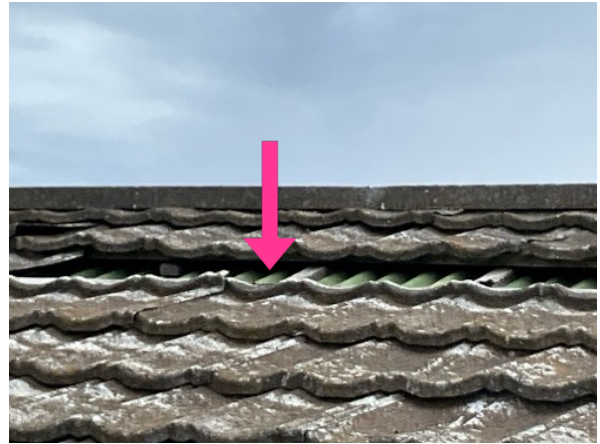
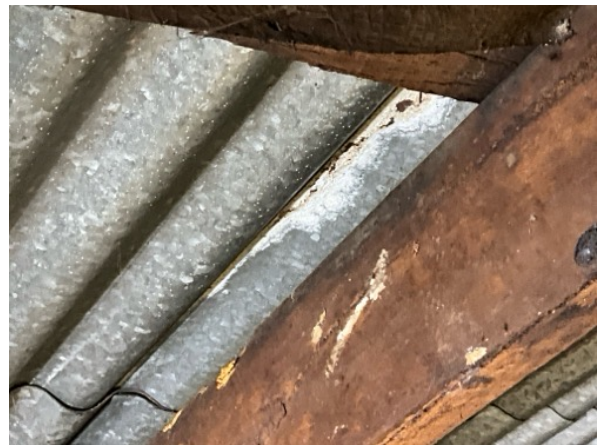
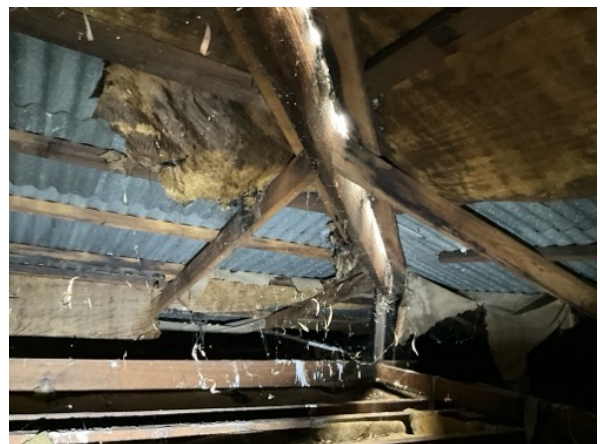
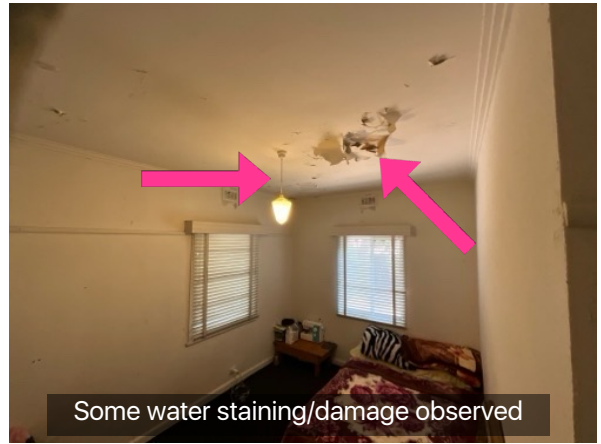
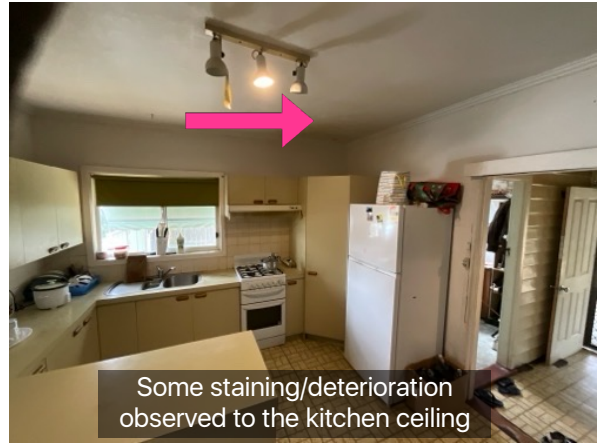
Major Defect 2.02

Finding: MAJOR DEFECT Holes in roof covering

The inspection of the roof exterior has revealed significant defects requiring immediate attention. The existing roof, originally constructed with corrugated iron, has been overlaid with metal roof tiles that are currently in poor condition. Numerous tiles are missing, likely due to storm damage, which has compromised the roof's integrity. The removal of the original ridge capping on the corrugated iron has further exacerbated the issue by allowing moisture ingress. The ridge capping and several roof tiles have blown off, resulting in visible open gaps that permit light and water into the roof cavity, as evidenced by the observed water staining and damage inside the structure. Additionally, some areas of corrosion are present on the roof sheets. It remains uncertain whether similar roof tiles are available for replacement, raising the possibility that a complete roof replacement may be necessary if repairs prove unfeasible. To address these issues, it is recommended that a qualified roofing specialist be engaged to assess the extent of the damage and determine whether partial repairs or a full replacement is advisable. Immediate remedial action is essential to prevent further water ingress and potential structural damage.

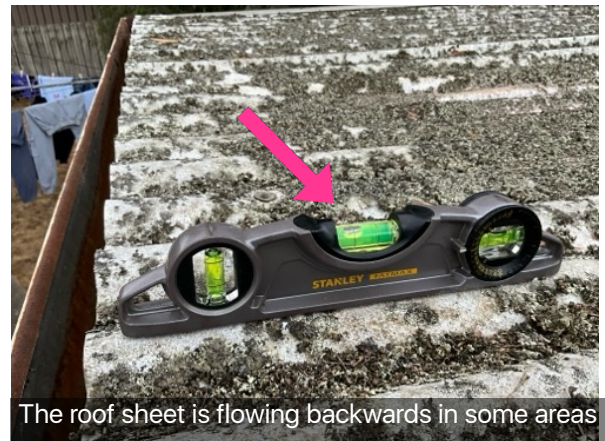
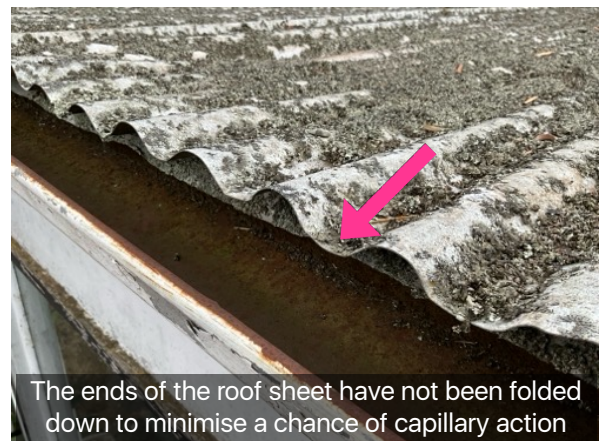
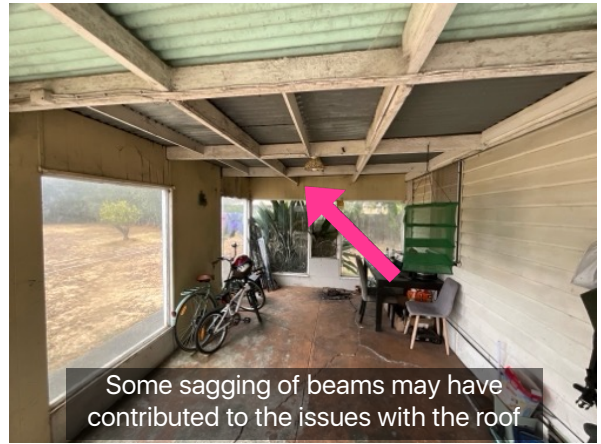
This roof has not been built to recognise standards with beam spanning excessive distances

- The verandah roof lacks adequate fall, resulting in water pooling on the roof and some leaks.
- Roof sheets don't have sufficient fall and flowing backwards in some sections.
- Sagging of beams due to the low standard of construction might be contributing to the roof fall issues.
- Some overlaps on the roof sheets are oriented incorrectly.
- Ends of the roof sheets are not folded down resulting in moisture leaks which has caused substantial deterioration to the internal lining.
- The gutter is corroded and improperly positioned.
- Window frames are in very poor condition and should be replaced.
- Broken asbestos sheeting has been observed which is a significant safety concern. [See separate defect statement]

These issues necessitate immediate attention to prevent further deterioration and ensure structural integrity. An investigation (by a competent person e.g. a licensed building contractor) is recommended as soon as possible to determine the method and extent of any remedial work required and associated costs.

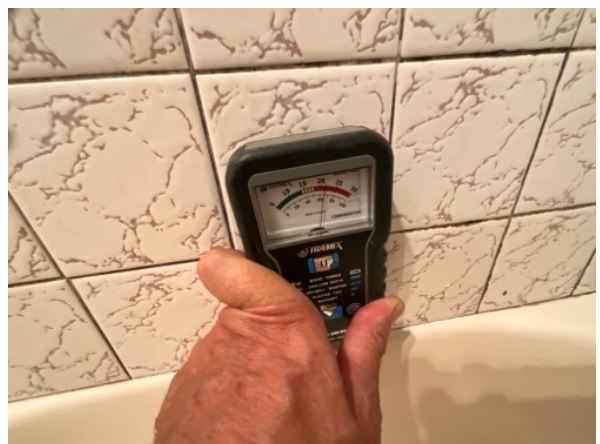
Minor Defect 3.01

The shower enclosure failed a moisture meter test which indicated moisture behind the lower wall tiles. [See photos attached for other issues requiring attention] Showers do require ongoing maintenance as grout can deteriorate over time often resulting in cracking and or pinholes to the finish of it reducing its capacity to effectively seal. Silicon should be used to seal all corner joints of tiling and where it meets baths, shower bases etc. Silicone sealants do have a limited lifespan and industry recommendations suggest it may require replacement after five years. Leaking showers can cause significant damage if left unrepaired. An investigation (by a competent person e.g. a bathroom specialist) is recommended as soon as possible to determine the method and extent of any remedial work required and associated costs.

Note: There was no visible signs observed of moisture affecting areas adjacent to the shower enclosure.

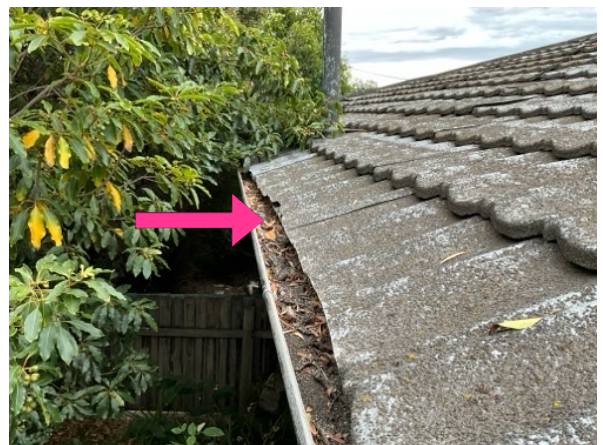
Minor Defect 3.03

Some gutters are dirty and require cleaning out. Dirty gutters will often result in a reduced service life as well as blocking the flow of water which in severe cases can result in gutters overflowing. [in some situations especially concealed gutters potentially impacting internal elements of the home] These gutters should be cleaned as soon as possible. An investigation (by a competent person e.g. a handyman) is recommended to determine the method and extent of any remedial work required and associated costs.

Note: The manufacturer Bluescope Steel says “Moisture or moisture retaining materials should not be permitted to remain in intimate contact with ZINCALUME® steel, COLORBOND® steel or galvanized steel. Such contact will ultimately result in corrosion of the material. The major factors influencing corrosion are the continual retention of moisture and the differential concentration of oxygen at the material surface. The accumulation of debris (leaf matter, dirt etc) which results in continual immersion, is the most common reason for unsatisfactory performance of guttering.”

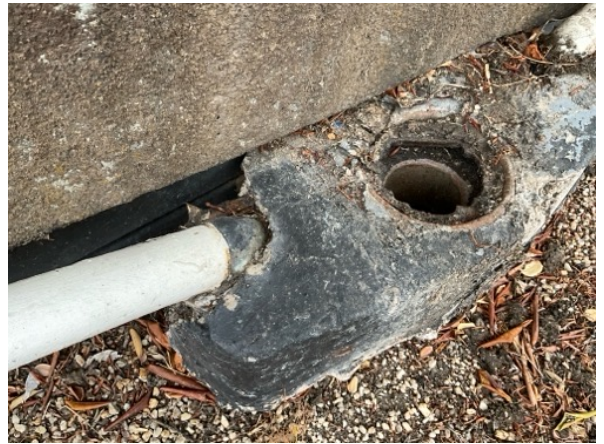
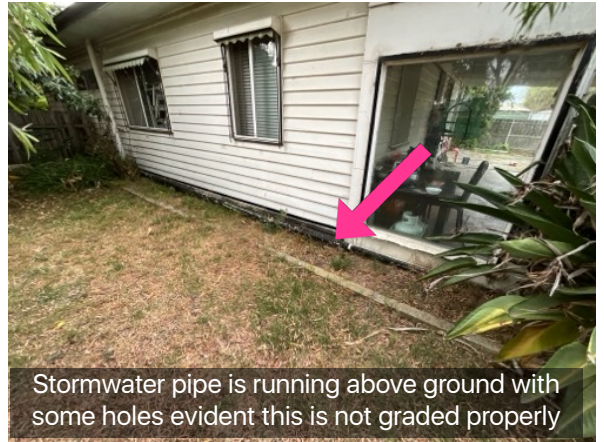
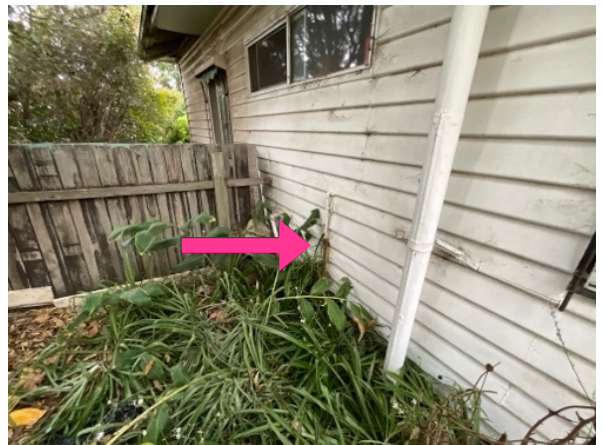
PVC pipes are now the industry standard and do not have the maintenance issues of clay pipes.

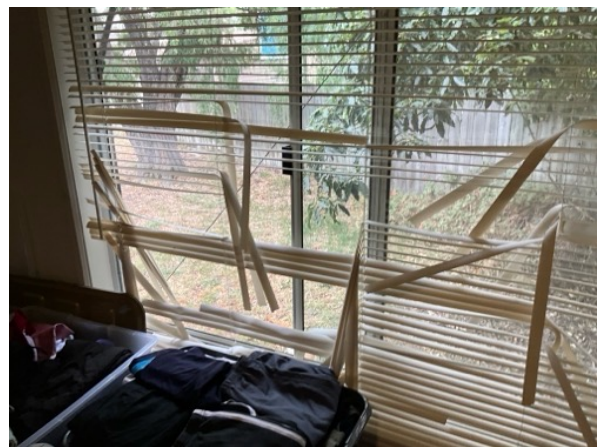
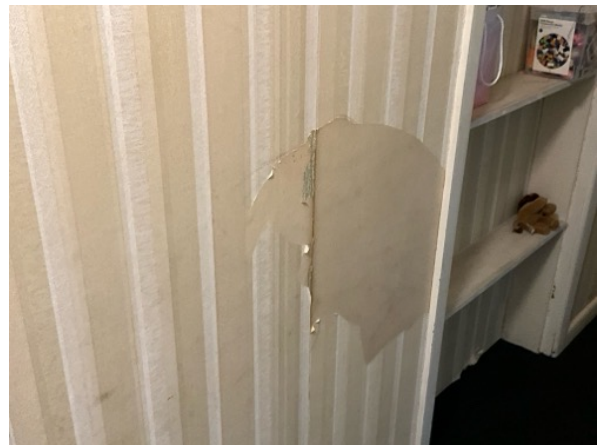
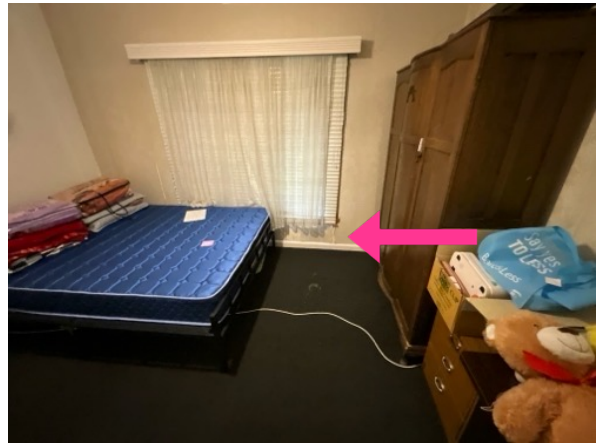
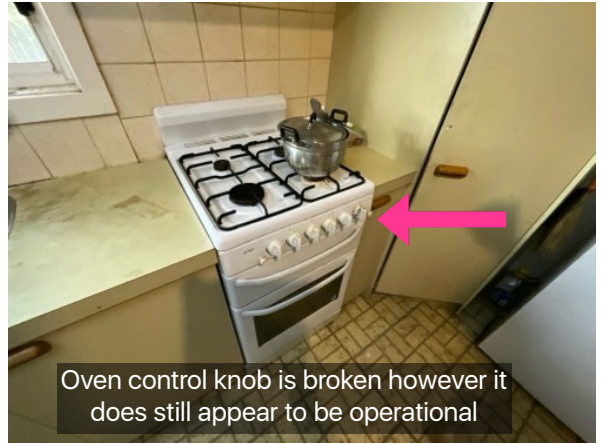
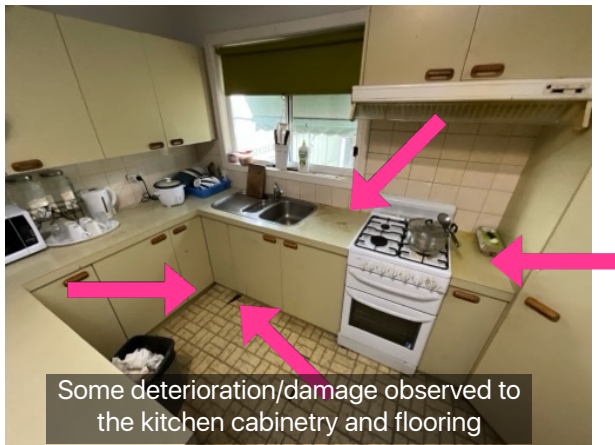
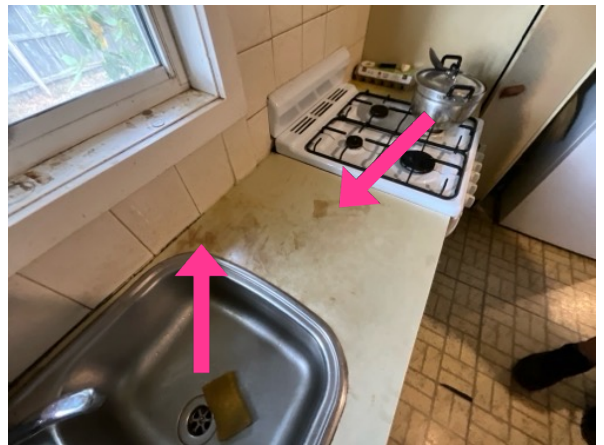
Minor Defect 3.06

Finding: Minor Defects

During the inspection of the property, it was noted that there are some minor defects present throughout the premises. The typical imperfections observed will often include cracks, surface rust, dents, and scratches in the plaster surfaces, fixtures, and fittings that are consistent with a home of this age. While these defects may be considered minor, it is important to note that they can still affect the overall condition and value of the property. The attached photos provide a visual representation of some of the defects observed, but this should not be taken as an exhaustive list. It is highly recommended that a qualified tradesperson be engaged to assess and rectify any defects that are not purely cosmetic in nature, in order to ensure the continued liveability of the home.

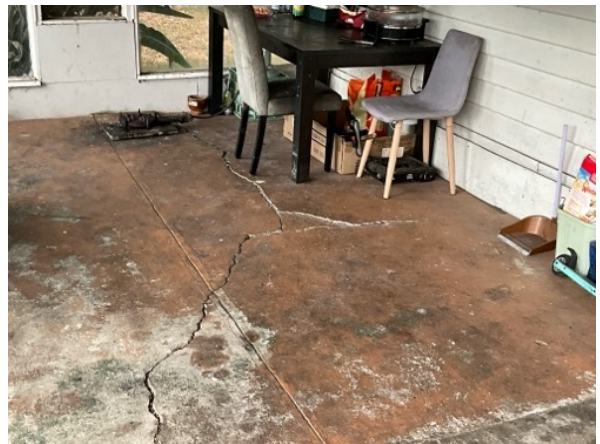
Minor Defect 3.07

Significant cracking and movement observed to the concrete

Some sections of the concrete should be replaced

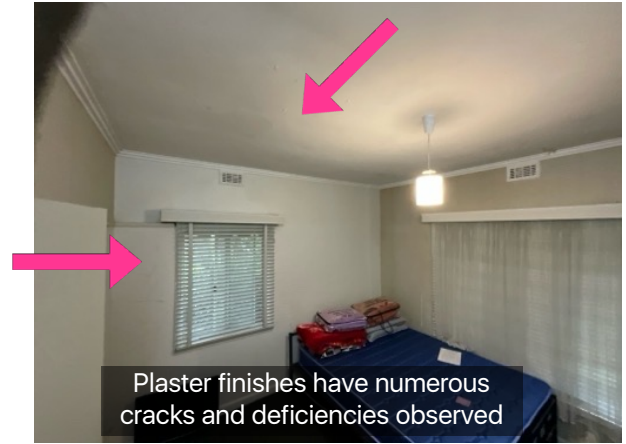
Numerous cracks observed to the plaster finishes throughout the home

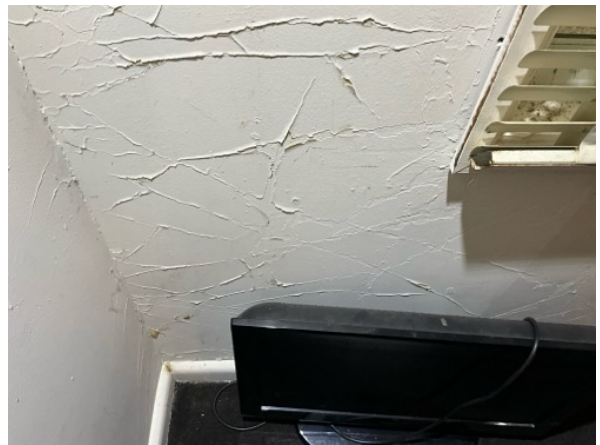
Plaster finishes have numerous cracks and deficiencies observed

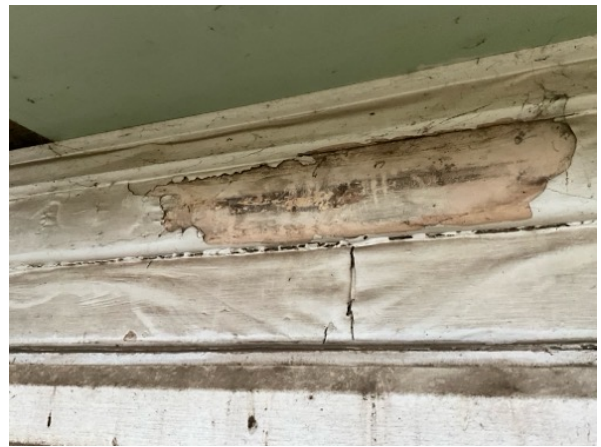
Minor Defect 3.09

Several areas of the external protective coatings [eg; paint, stains etc] have been neglected and require attention, [see photos for areas of concern]. Areas where finishes are in poor condition, potentially accelerate the deterioration of underlying building materials. Degraded finishes should be properly prepared prior to re-coating according to the manufactures instructions of the coating being utilised. An investigation (by a competent person e.g. a painting contractor) is recommended to determine the method and extent of any remedial work required and associated costs.

Note: Stains and oil coatings utilised on timber work generally require a more regular maintenance regime as they tend to deteriorate quicker that paints.

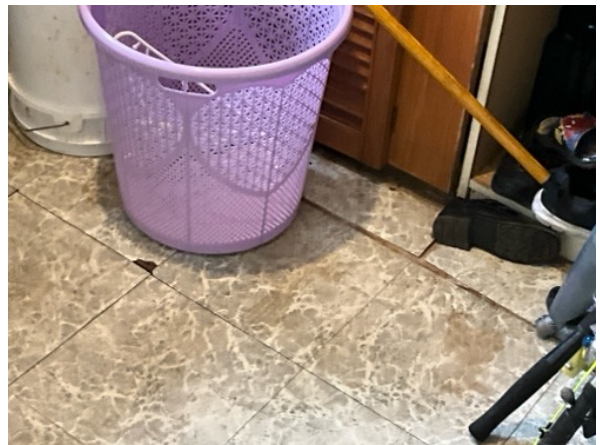
Minor Defect 3.12

Finding: Floor Coverings

Floor coverings are original with some deficiencies observed. (Some photo examples following) This could be aesthetically improved with the installation of new coverings. An investigation (by a competent person e.g. a floor covering specialist) is recommended to determine the method and extent of any remedial work required and associated costs.

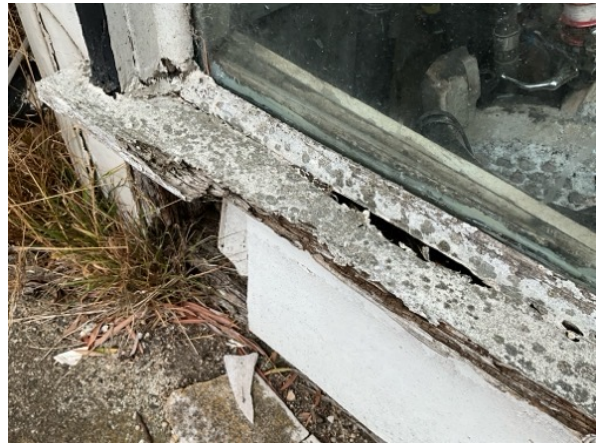
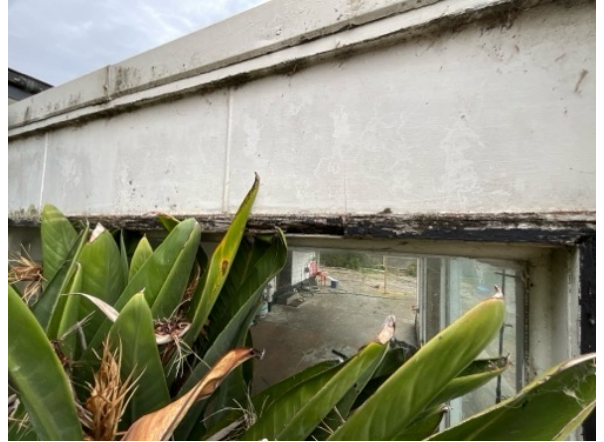
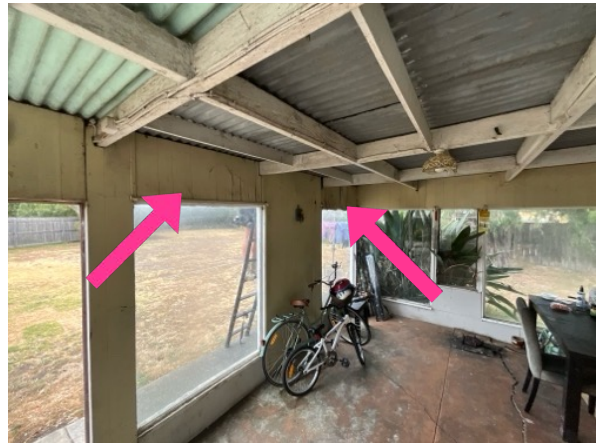
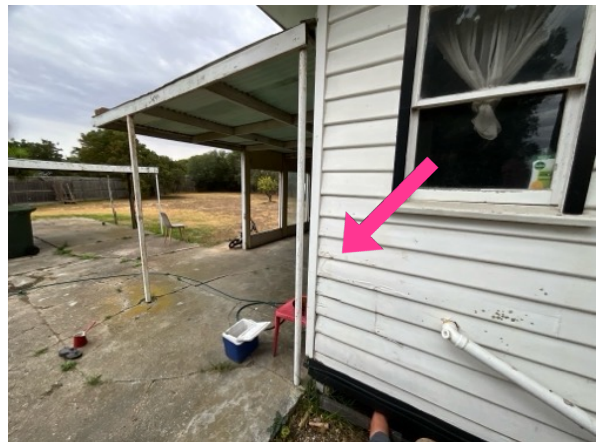
Exterior timber surfaces are showing signs of fungal decay in areas. (Some photo examples following) Recommend getting builder in to assess timbers and replace where necessary. A painter should then bring the paintwork back to a good standard. All timber surfaces require a regular maintenance regime as wood rot will often extend beneath painted surfaces and requires a detailed inspection (tapping) to identify.

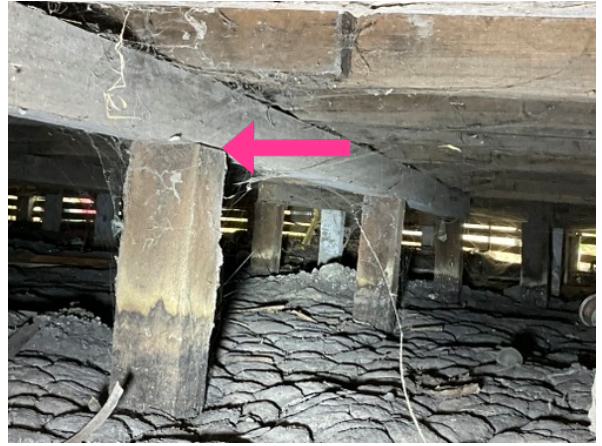
Finding: No ant caps

Timber stumps have been used in the subfloor area of the home and untreated timber is in direct contact with the earth. This long term will most often result in fungal decay of the post. This also presents conditions where undetected termite attack is possible and as there are no ant caps this increases the risk of concealed attack to the home. An investigation (by a competent person e.g. a licensed re-stumping contractor) is recommended to determine the method and extent of any remedial work required and associated costs.

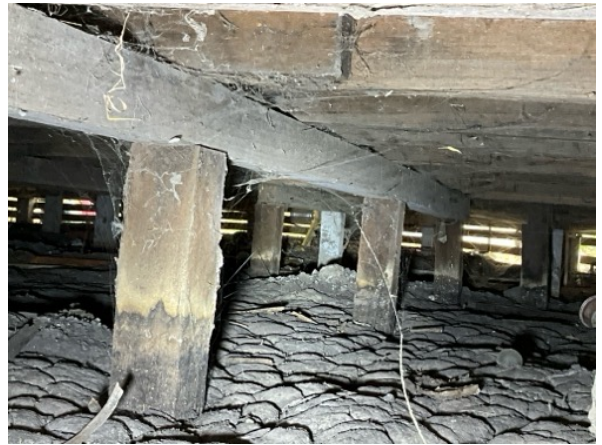
Conditions conducive to timber pest attack 5.08

Finding: Untreated timber stumps

It was noted that the property has timber stumps. Inspection of the condition of the timber stumps - below the surface of the ground - is excluded from the scope of this report. Where timber stumps are failing, replacement of stumps may be required in the short term future. Timber stumps are no longer used in current building practices due to their susceptibility to wood rot and deterioration over time. The client should be prepared that in purchasing a property with timber stumps, that the need to restump the property in the short term future is recommended.

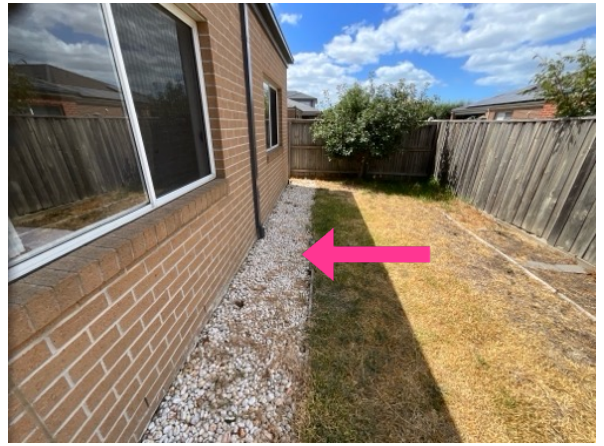
Minor Defect 1.02

Finding: Drainage

The site drainage in certain areas of the property could be improved. It is crucial to ensure that water does not accumulate against the base of walls as this can lead to foundation issues and create a favorable environment for timber pests. To mitigate these risks, it is advisable to slope the surrounding paths and ground levels adjoining the residence at a rate of 50mm per 1m to effectively drain water away from the walls. Additionally, CSIRO recommends maintaining a concrete apron measuring 1m wide around the property to help maintain footing integrity. Regular inspections after significant rainfall are recommended to identify any areas where water may be pooling or excessive moisture is present near the structure. An investigation (by a competent person e.g. a landscape contractor) is recommended to determine the method and extent of any remedial work required and associated costs.

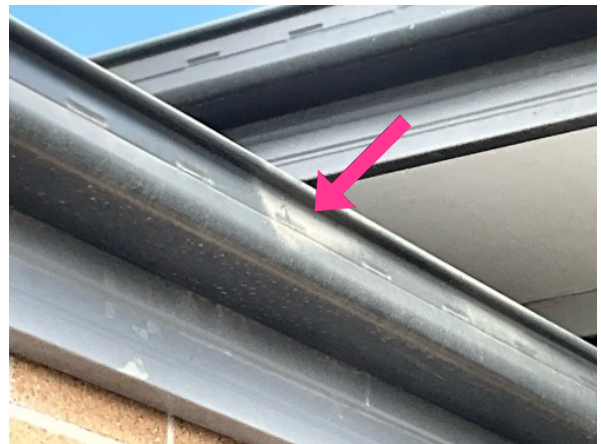
Minor Defect 1.03

BlueScope does not recommend the use of touch-up paint to repair damage or scratches to the painted surface. As explained above, air-drying paints have different weathering characteristics to COLORBOND® steel, which leads to variations in appearance over time where touch-up paint has been used. BlueScope does not have a recommended method for the removal of touch-up paint. Minor scratches (< 2mm in width) should be left alone as the available metallic coating will continue to protect against corrosion providing the scratches are superficial and the metallic coating is not damaged. If scratches are more noticeable on new material, it is the recommendation of BlueScope to replace the affected product.

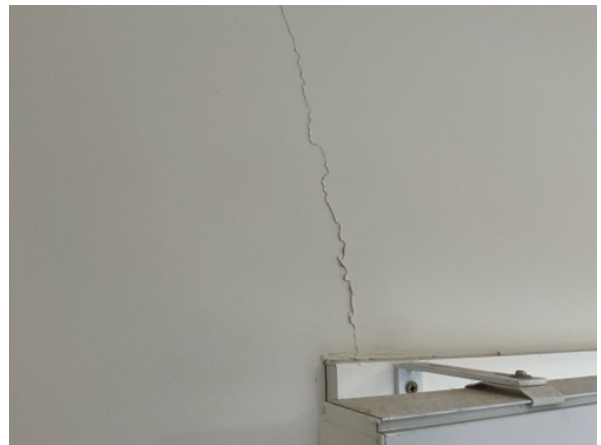
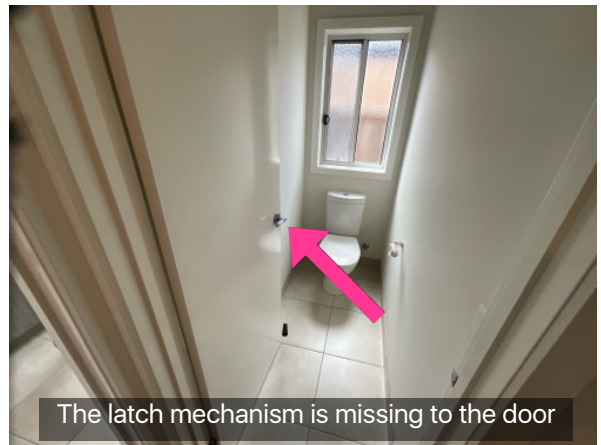
Finding: Minor Defects

During the inspection of the property, it was noted that there are some minor defects present throughout the premises. The typical imperfections observed will often include cracks, surface rust, dents, and scratches in the plaster surfaces, fixtures, and fittings that are consistent with a home of this age. While these defects may be considered minor, it is important to note that they can still affect the overall condition and value of the property. The attached photos provide a visual representation of some of the defects observed, but this should not be taken as an exhaustive list. It is highly recommended that a qualified tradesperson be engaged to assess and rectify any defects that are not purely cosmetic in nature, in order to ensure the continued liveability of the home.

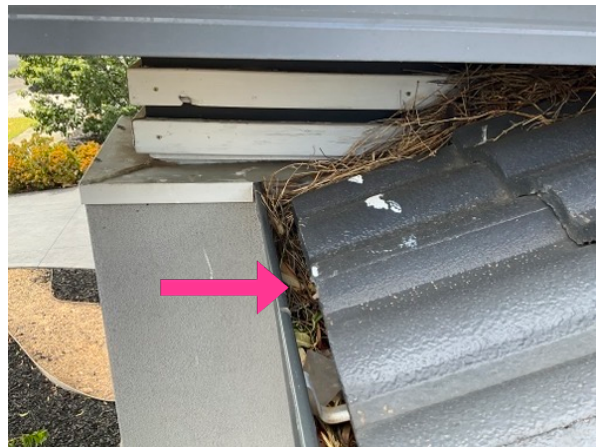
Minor Defect 1.07

Some gutters are dirty and require cleaning out. Dirty gutters will often result in a reduced service life as well as blocking the flow of water. In severe cases this can result in gutters overflowing and in some situations, especially concealed gutters, potentially impacting internal elements of the home. These gutters should be cleaned as soon as possible. Where there is vegetation on the roof this should be removed to prevent deterioration occurring to the roof sheet. An investigation (by a competent person e.g. a handyman) is recommended to determine the method and extent of any remedial work required and associated costs.

Note: The manufacturer Bluescope Steel says “Moisture or moisture retaining materials should not be permitted to remain in intimate contact with ZINCALUME® steel, COLORBOND® steel or galvanized steel. Such contact will ultimately result in corrosion of the material. The major factors influencing corrosion are the continual retention of moisture and the differential concentration of oxygen at the material surface. The accumulation of debris (leaf matter, dirt etc) which results in continual immersion, is the most common reason for unsatisfactory performance of guttering.”

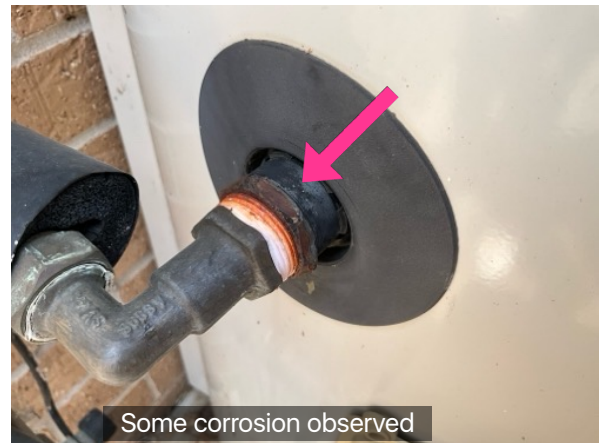
Minor Defect 1.10

Note: If the solar storage tank component is unserviceable it should be decommissioned and the instant hot water unit should still provide hot water. These solar boosted storage tanks in the past have not had a great service life and may not be worthwhile to replace it.

An investigation (by a competent person e.g. a licensed plumbing contractor) is recommended to determine the method and extent of any remedial work required, and associated costs.

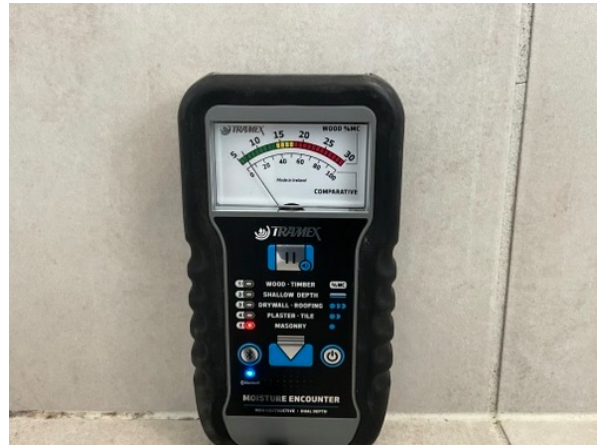
Finding: Moisture meter

When using a Tramex moisture meter within the shower enclosure, the readings were considered to be within the acceptable range.

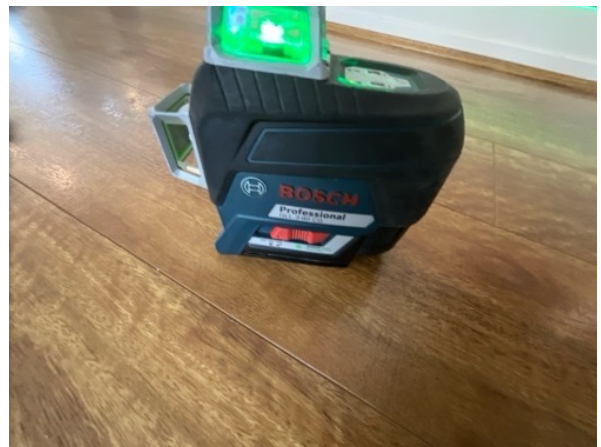
For your information 2.03

Finding: Laser level

A laser level was used to check the floor levels throughout the home. Only minor variations were observed and considered to be within acceptable tolerances.
