3x Sample Property and Timber Pest Reports

Property and Timber Pest Report

Inspection Date: 6 Mar 2026

Property Address: 01 Sample st Armstrong Creek

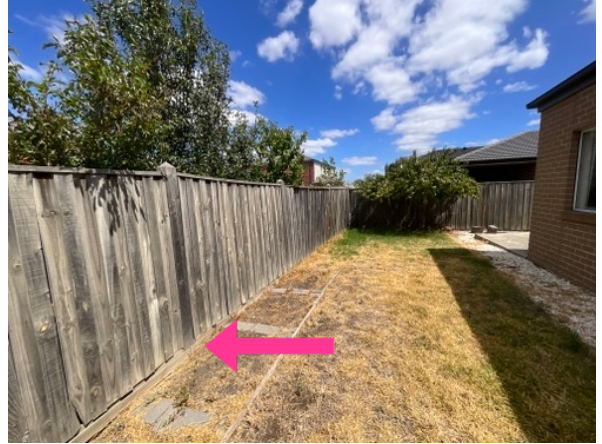
etc Recommend to minimise food sources for termites by removing areas of concern.
(See photos attached)
