3x Sample Property and Timber Pest Reports

Property and Timber Pest Report

Inspection Date: 6 Mar 2026

Property Address: 01 Sample st Armstrong Creek

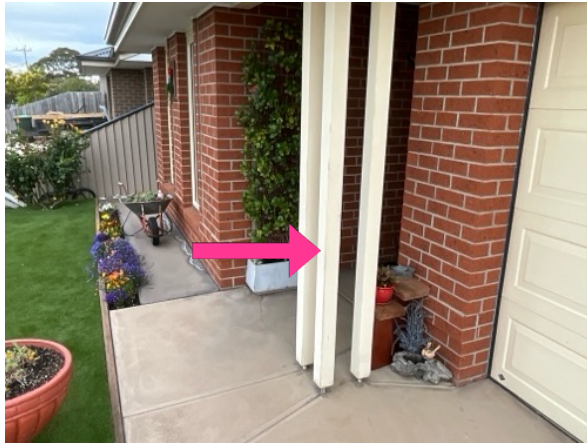
Minor Defect 2.05

Some minor cracks and movement less than 3mm in width were observed in the brickwork around the home. This would be graded as a category 2 crack by the below table. Recommend to monitor crack and if it increases in width to get a more detailed investigation by a competent person, (e.g. a licensed building contractor) to determine the method and extent of any remedial work required and associated costs.

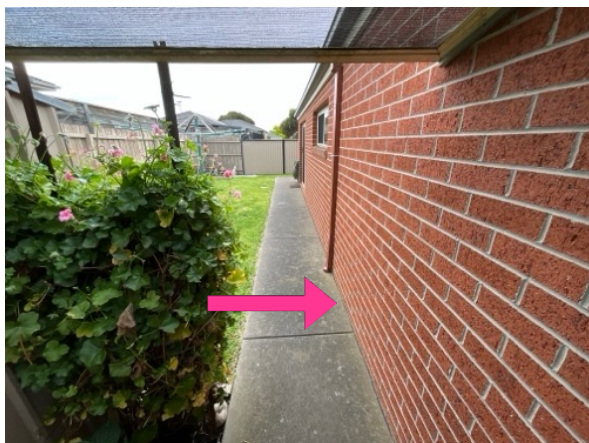
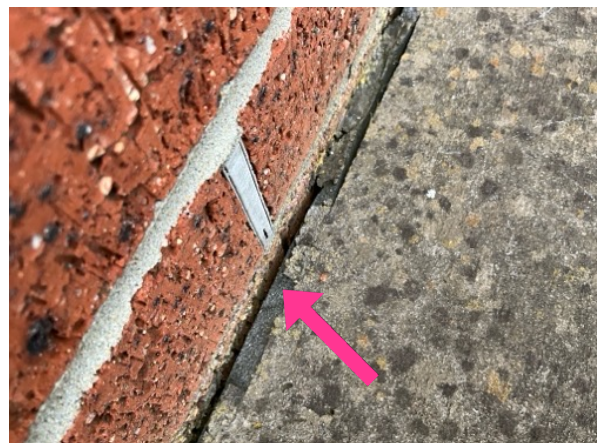
Minor Defect 2.06

The concrete paving against the home has pulled away. This is not unusual and often has happened over many years of varying ground changes. On areas where walls are exposed to driving rain it can be beneficial to seal the gap, (recommend a good polyurathane sealant), from the brickwork to the paving. This protects the foundations from excessive moisture which long term can cause foundation issues if not corrected. An investigation (by a competent person e.g. a handyman) is recommended to determine the method and extent of any remedial work required and associated costs.

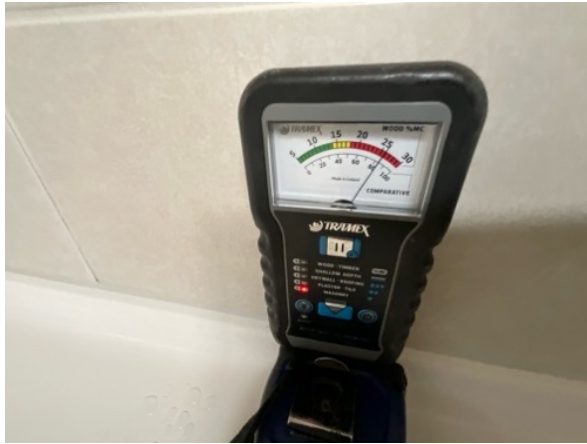
Conditions conducive to timber pest attack 4.01

Finding: Moisture in shower

There was detected high levels of moisture behind the wall tiles in the shower (see photos attached) this is indicative of moisture ingress past the outer layer of the enclosure. [See separate defect statement in building report] Excessive moisture is always concerning as it results in conditions conducive towards timber pest activity. [fungal decay, termites etc] An investigation (by a competent person e.g. a bathroom specialist) is recommended to determine the method and extent of any remedial work required and associated costs.

Note: Where there has been installed a waterproof membrane behind the tiles this moisture may have been prevented from affecting the internal elements of the building. This cannot be verified without a more invasive investigation.

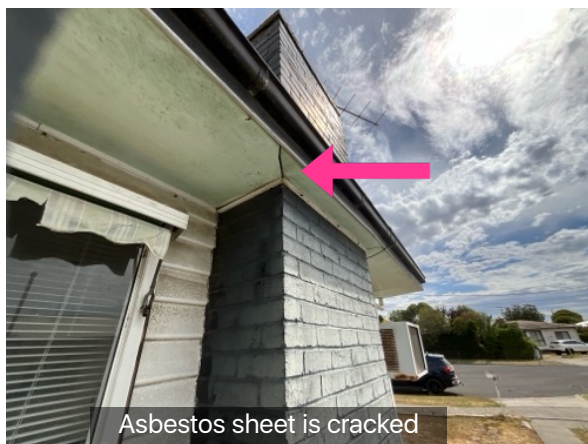
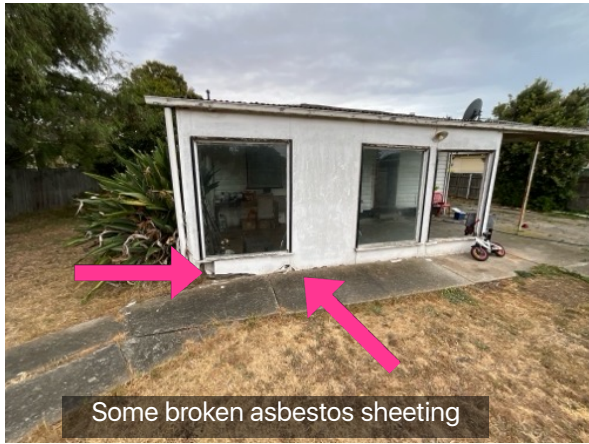
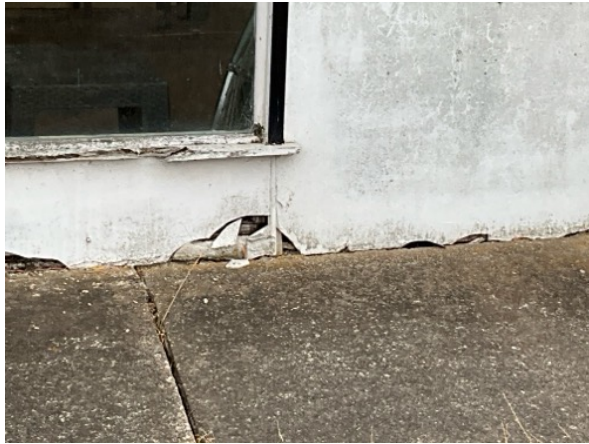
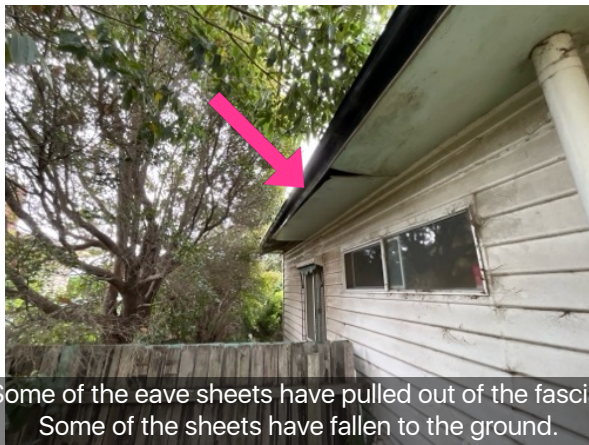
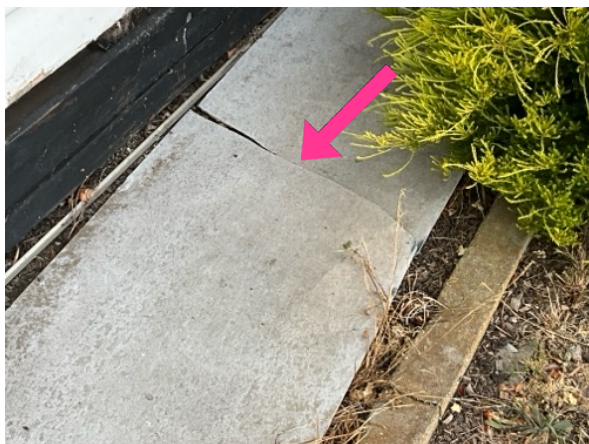
Finding: Asbestos?

The property presents a significant safety concern due to compromised cement sheeting, likely containing asbestos fibers. Examination reveals numerous sheets throughout the property that are cracked or broken, with several instances of eave sheets having detached from the fascia and fallen to the ground. Disturbingly, some of these fallen sheets have been repurposed as baseboards, increasing the risk of exposure to potentially harmful asbestos fibers. Furthermore, it is most likely that there are loose fibers on the ground where asbestos sheeting has been cut, posing an inhalation risk. Many of the eave sheets are not securely fastened, heightening the danger of further detachment. Overall this situation constitutes a severe hazard, and it is strongly recommended that the property remain unoccupied until a comprehensive inspection and analysis are conducted by an asbestos specialist. Immediate remedial action is advised to mitigate any health risks. It is crucial to engage a licensed professional to assess the extent of asbestos presence and execute safe removal and disposal of affected materials. Additionally, reinforcing or replacing the unsecured sheeting should be carried out to prevent future incidents. Implementing these measures is essential to ensure the safety and integrity of the property before habitation can be considered.

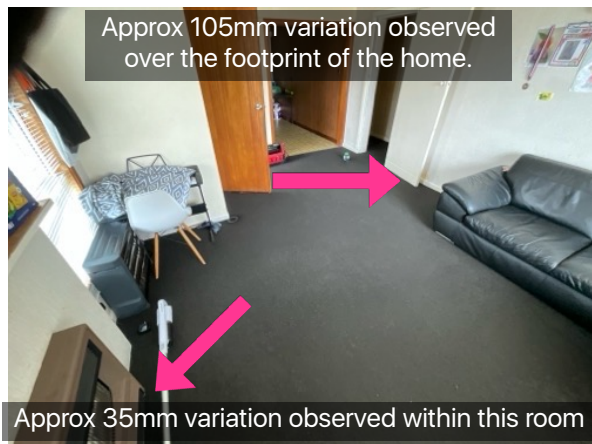
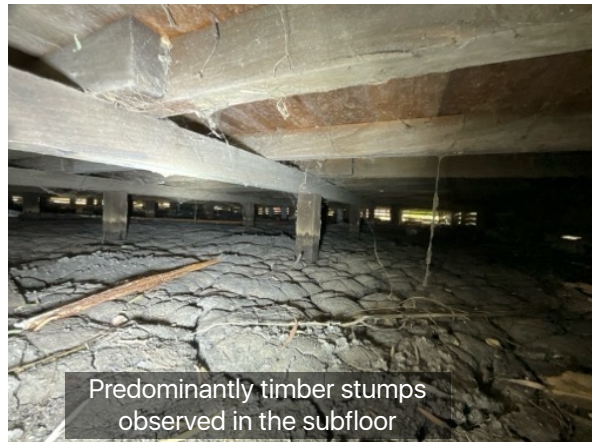
Note: Some of the house is low to the ground when restumping it would probably entail lifting internal floorboards to access the stumps.

A further detailed investigation (by a competent person e.g. a licensed engineer/underpinning contractor) is recommended to determine the method and extent of any remedial work required and associated costs.

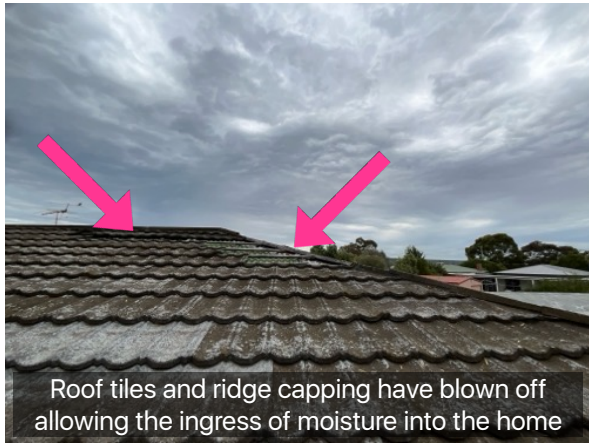
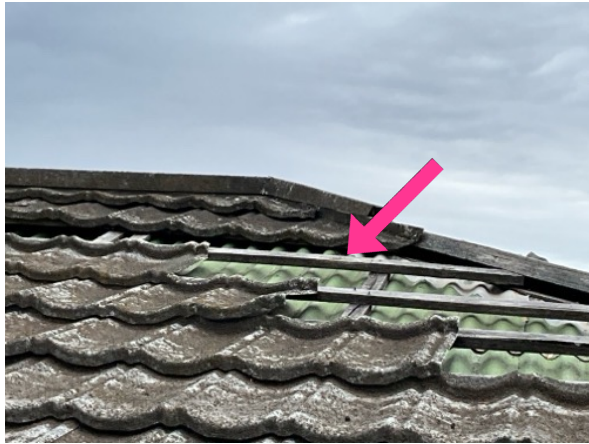
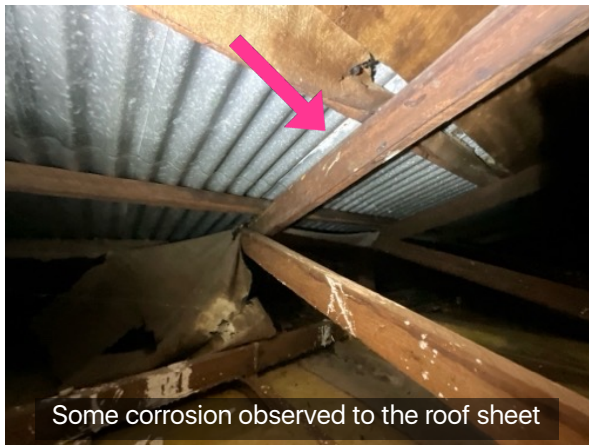
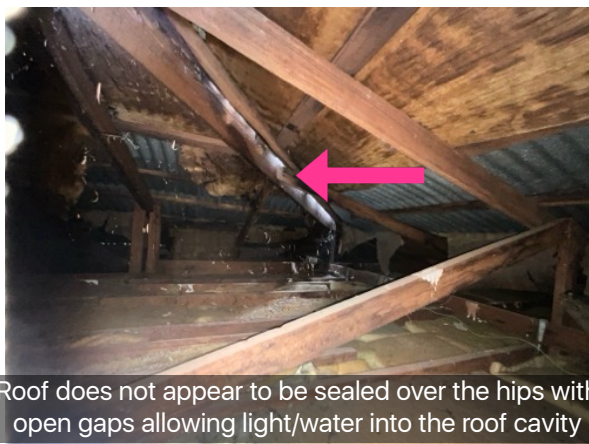
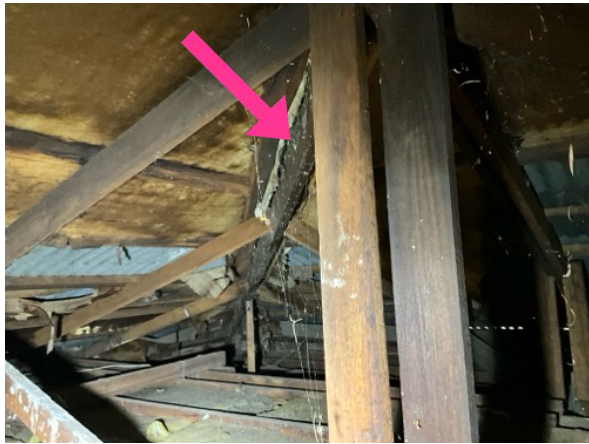
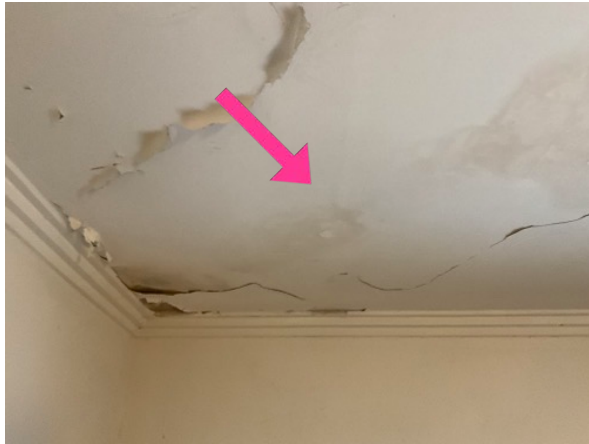
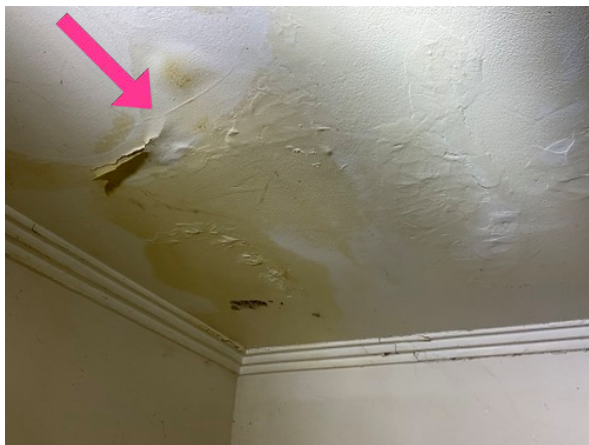
Major Defect 2.02

Location: Roof exterior

Finding: MAJOR DEFECT Holes in roof covering

The inspection of the roof exterior has revealed significant defects requiring immediate attention. The existing roof, originally constructed with corrugated iron, has been overlaid with metal roof tiles that are currently in poor condition. Numerous tiles are missing, likely due to storm damage, which has compromised the roof's integrity. The removal of the original ridge capping on the corrugated iron has further exacerbated the issue by allowing moisture ingress. The ridge capping and several roof tiles have blown off, resulting in visible open gaps that permit light and water into the roof cavity, as evidenced by the observed water staining and damage inside the structure. Additionally, some areas of corrosion are present on the roof sheets. It remains uncertain whether similar roof tiles are available for replacement, raising the possibility that a complete roof replacement may be necessary if repairs prove unfeasible. To address these issues, it is recommended that a qualified roofing specialist be engaged to assess the extent of the damage and determine whether partial repairs or a full replacement is advisable. Immediate remedial action is essential to prevent further water ingress and potential structural damage.

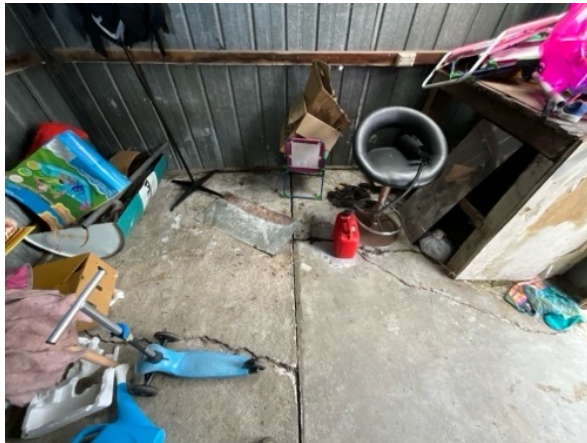
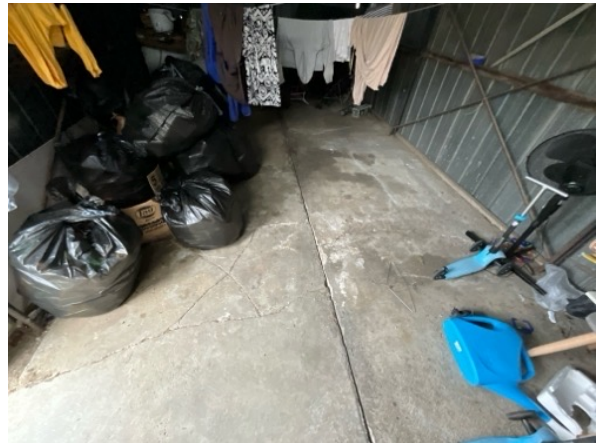
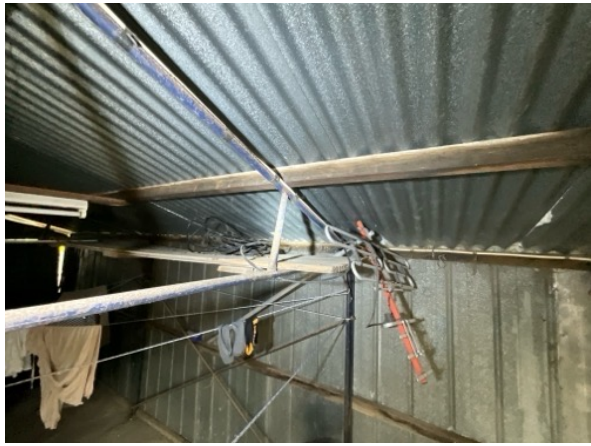
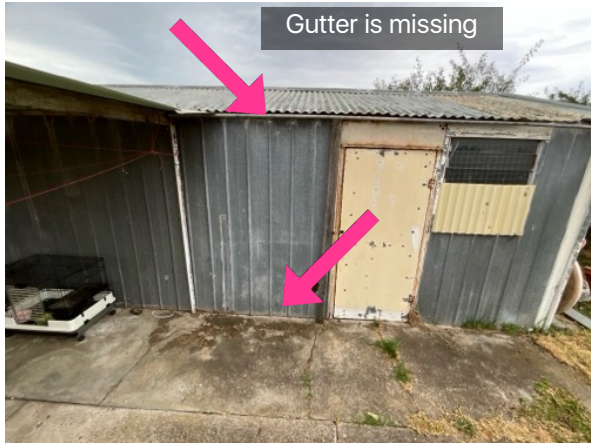
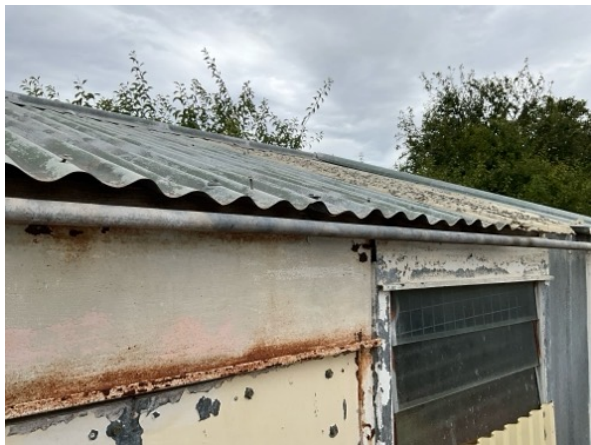
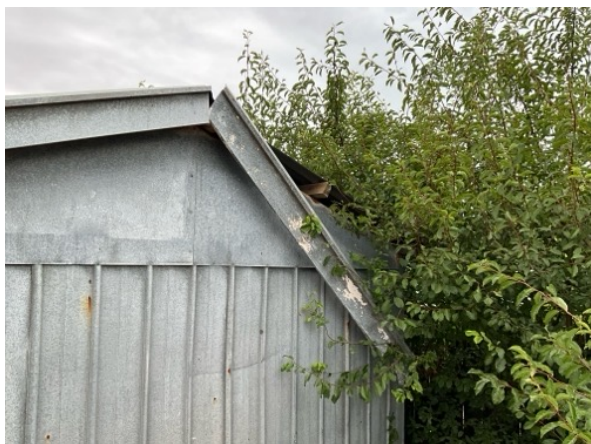
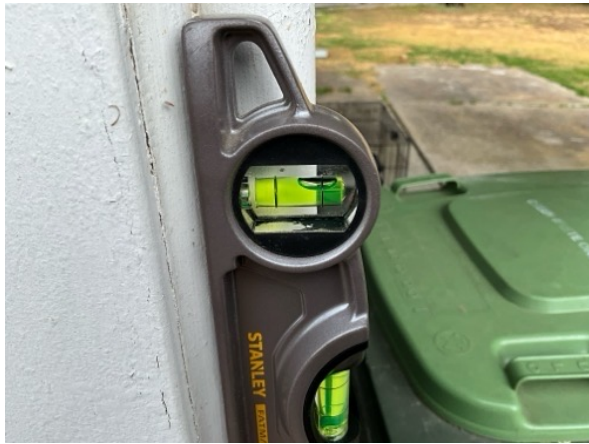
Major Defect 2.03

Location: Garage

- The wall & roof materials are corroded in places. This may have some service life remaining but should be monitored for any leaks that may develop.

Given the extent and nature of the damage, it is recommended that the garage and lean-to roof be assessed for complete removal and replacement rather than repair. This approach is likely to be more economical in the long term, ensuring compliance with current building standards and providing a safe, durable structure. Professional assessment and intervention are advised to address these issues comprehensively.

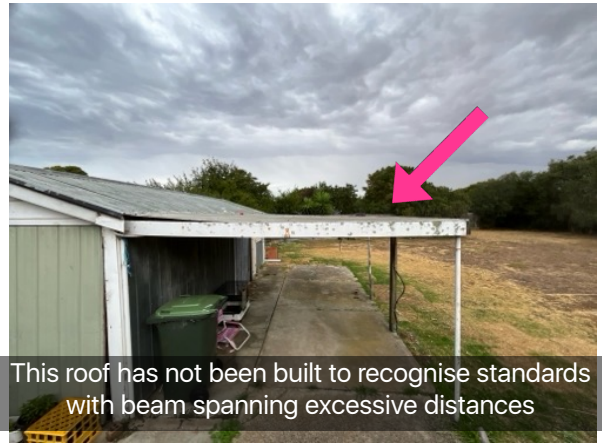
This roof has not been built to recognise standards with beam spanning excessive distances

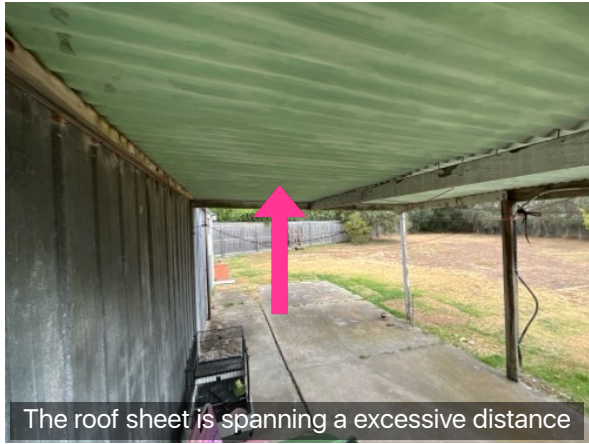
The roof sheet is spanning a excessive distance

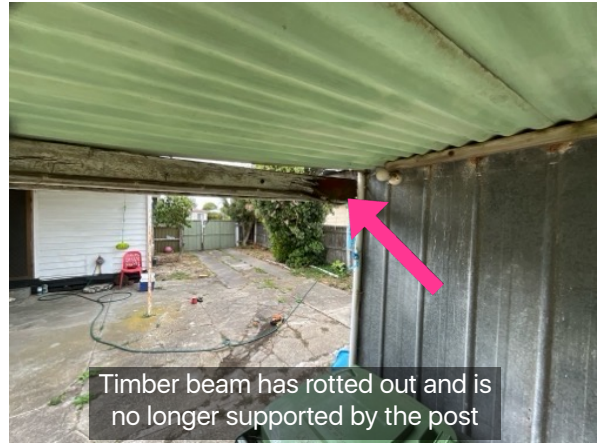
Timber beam has rotted out and is no longer supported by the post

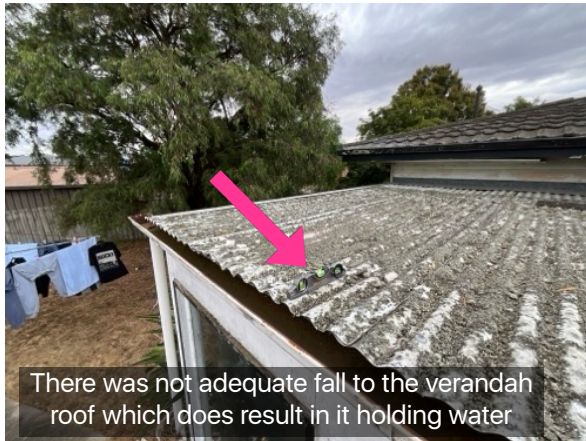
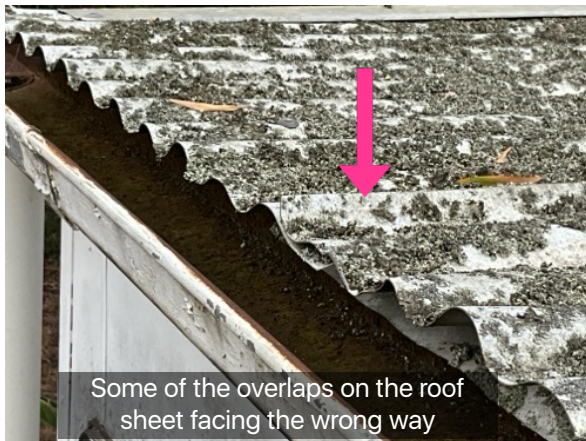
Major Defect 2.04

Location: Exterior

- The verandah roof lacks adequate fall, resulting in water pooling on the roof and some leaks.
- Roof sheets don't have sufficient fall and flowing backwards in some sections.
- Sagging of beams due to the low standard of construction might be contributing to the roof fall issues.
- Some overlaps on the roof sheets are oriented incorrectly.
- Ends of the roof sheets are not folded down resulting in moisture leaks which has caused substantial deterioration to the internal lining.
- The gutter is corroded and improperly positioned.
- Window frames are in very poor condition and should be replaced.
- Broken asbestos sheeting has been observed which is a significant safety concern. [See separate defect statement]

These issues necessitate immediate attention to prevent further deterioration and ensure structural integrity. An investigation (by a competent person e.g. a licensed building contractor) is recommended as soon as possible to determine the method and extent of any remedial work required and associated costs.

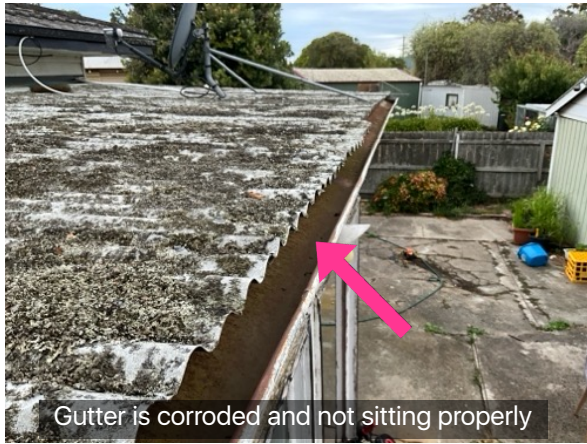
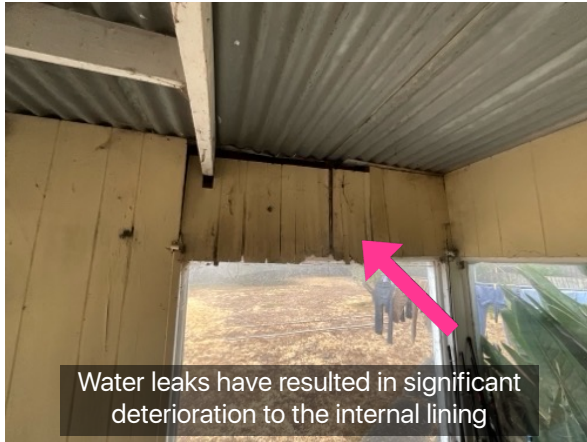
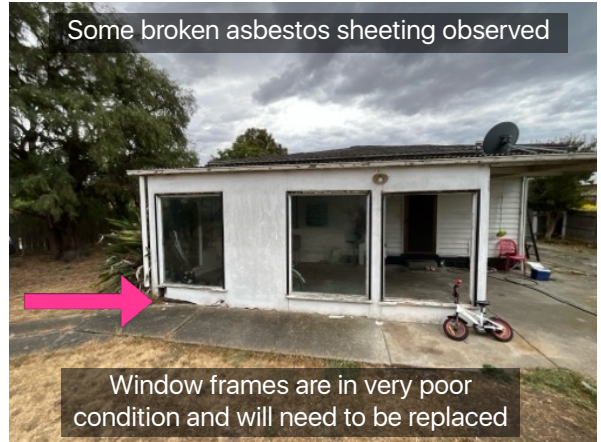
Finding: MAJOR DEFECT Verandah area

The verandah area is in a significantly deteriorated condition and necessitates considerable repairs, which may not be economically viable. Several areas of concern have been identified and require rectification. The observed defects are as follows:

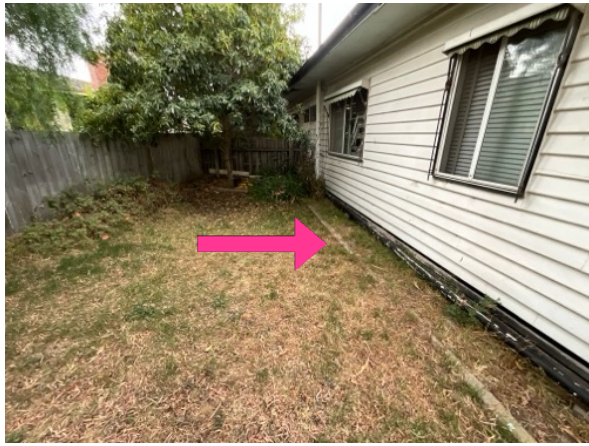
Minor Defect 3.01

Finding: Drainage

The site drainage in certain areas of the property could be improved. It is crucial to ensure that water does not accumulate against the base of walls as this can lead to foundation issues and create a favorable environment for timber pests. To mitigate these risks, it is advisable to slope the surrounding paths and ground levels adjoining the residence at a rate of 50mm per 1m to effectively drain water away from the walls. Additionally, CSIRO recommends maintaining a concrete apron measuring 1m wide around the property to help maintain footing integrity. Regular inspections after significant rainfall are recommended to identify any areas where water may be pooling or excessive moisture is present near the structure. An investigation (by a competent person e.g. a landscape contractor) is recommended to determine the method and extent of any remedial work required and associated costs.

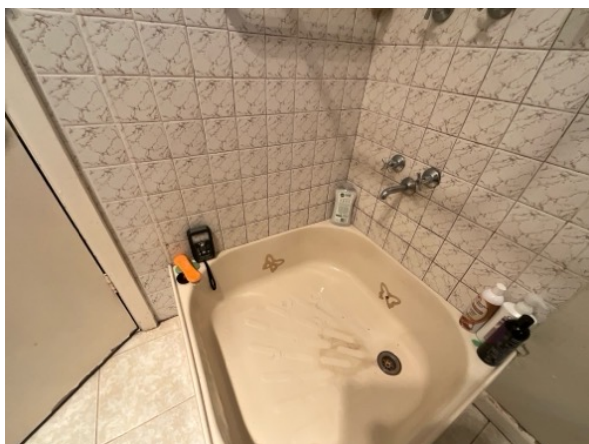
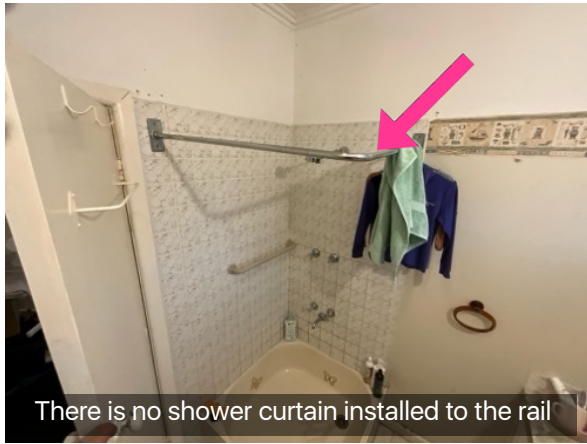
Minor Defect 3.02

The shower enclosure failed a moisture meter test which indicated moisture behind the lower wall tiles. [See photos attached for other issues requiring attention] Showers do require ongoing maintenance as grout can deteriorate over time often resulting in cracking and or pinholes to the finish of it reducing its capacity to effectively seal. Silicon should be used to seal all corner joints of tiling and where it meets baths, shower bases etc. Silicone sealants do have a limited lifespan and industry recommendations suggest it may require replacement after five years. Leaking showers can cause significant damage if left unrepaired. An investigation (by a competent person e.g. a bathroom specialist) is recommended as soon as possible to determine the method and extent of any remedial work required and associated costs.

Note: There was no visible signs observed of moisture affecting areas adjacent to the shower enclosure.

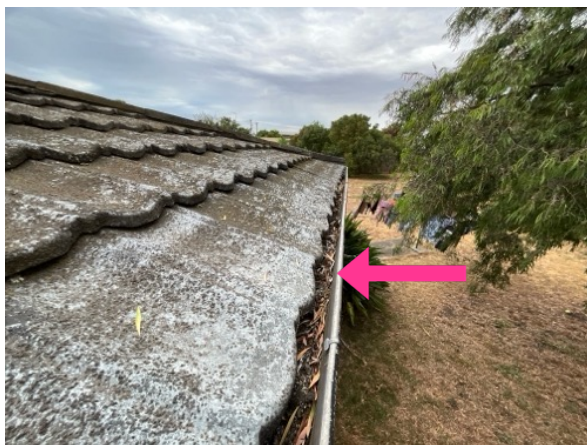
Minor Defect 3.03

Some gutters are dirty and require cleaning out. Dirty gutters will often result in a reduced service life as well as blocking the flow of water which in severe cases can result in gutters overflowing. [in some situations especially concealed gutters potentially impacting internal elements of the home] These gutters should be cleaned as soon as possible. An investigation (by a competent person e.g. a handyman) is recommended to determine the method and extent of any remedial work required and associated costs.

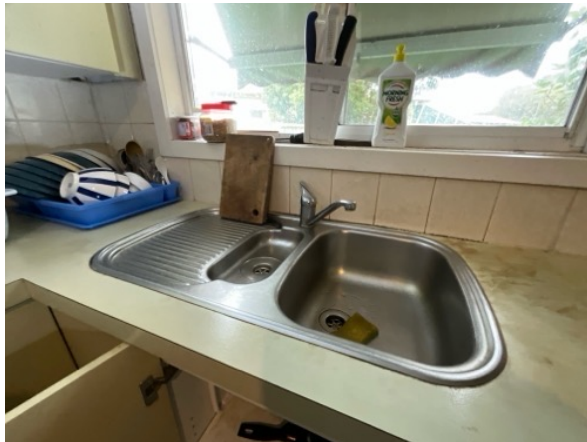
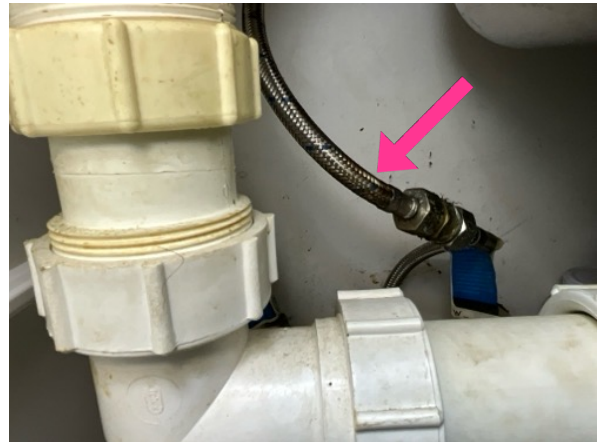
Minor Defect 3.04

Finding: Flexible hoses corroded

Some corrosion was observed to flexible water hoses which are used for connecting plumbing fixtures. (See photos attached) Recommend getting all flexible hoses checked by a plumber and replaced where necessary as a burst hose can cause significant water damage due to constant pressure.

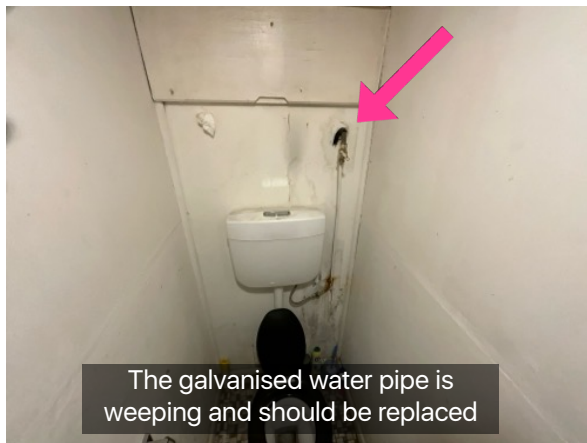
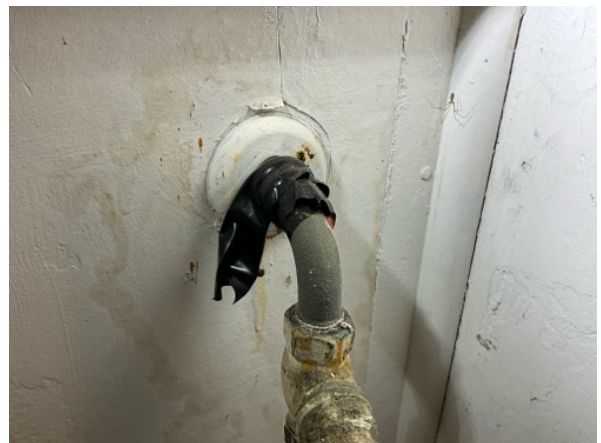
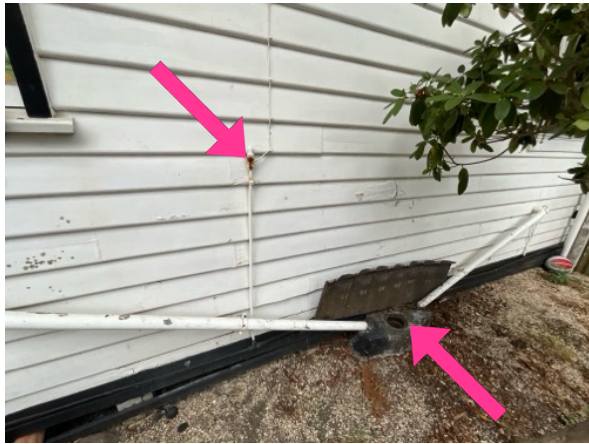
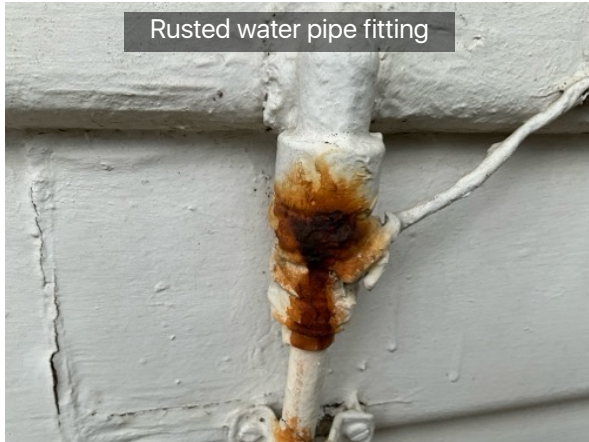
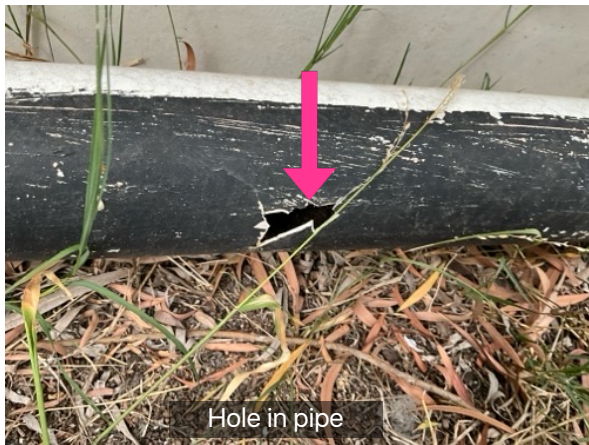
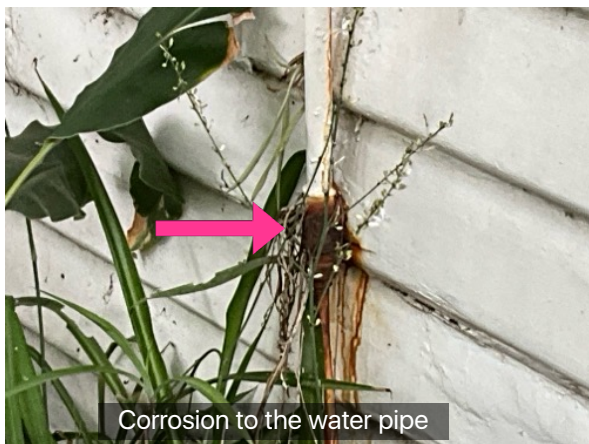
Minor Defect 3.05

There are several areas of concern observed with the old plumbing pipes that typically have a finite service life. The pipes of concern are as follows:

The home has some galvanised water fittings/pipe supplying the home with some corrosion and leaks observed. This should be repaired as soon as possible as excessive moisture can cause conditions conducive towards timber pest activity and further deterioration of building elements.

Some of the metal plumbing fittings are older and are often corroded internally. These may have limited service life remaining.

There was some older clay pipes observed leading into the ground. These pipes will often leak at joints which then attract tree roots causing blockages. They also become brittle with age and can easily break. When pipes leak it results in excessive moisture in an area which can cause foundation issues, as well as conditions conducive towards timber pest activity. It is not uncommon for clay pipes to have to be replaced with PVC pipes when they are no longer serviceable. An investigation (by a competent person e.g. a licensed plumbing contractor) is recommended as soon as possible to determine the method and extent of any remedial work required and associated costs.

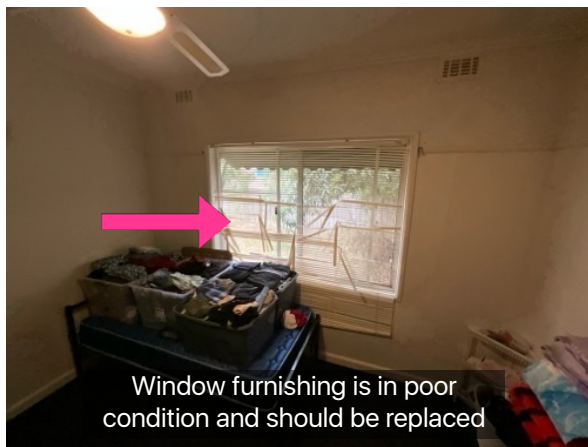
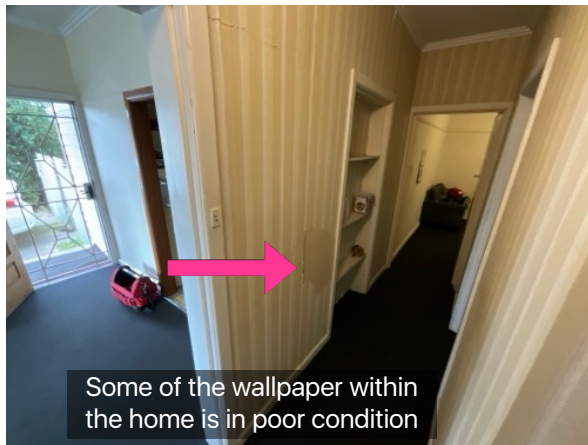
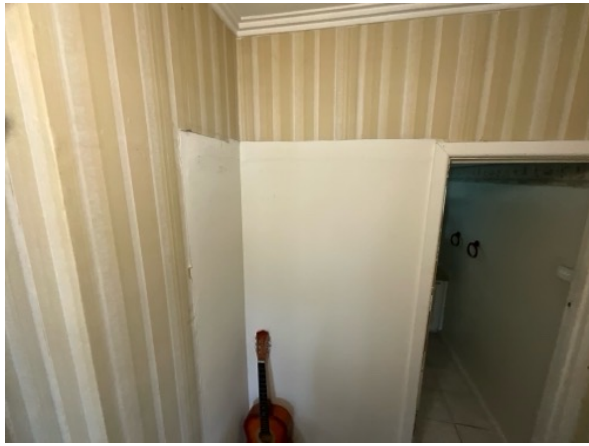
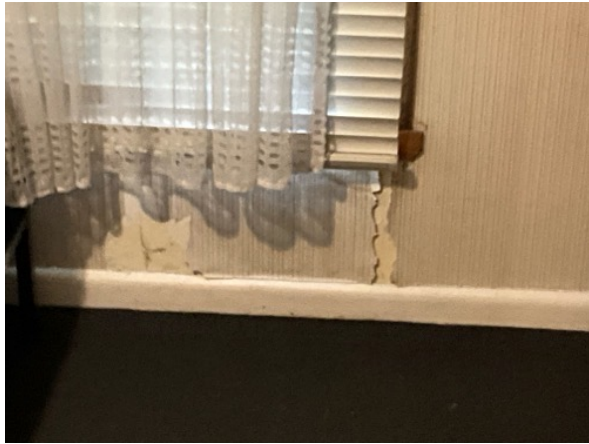
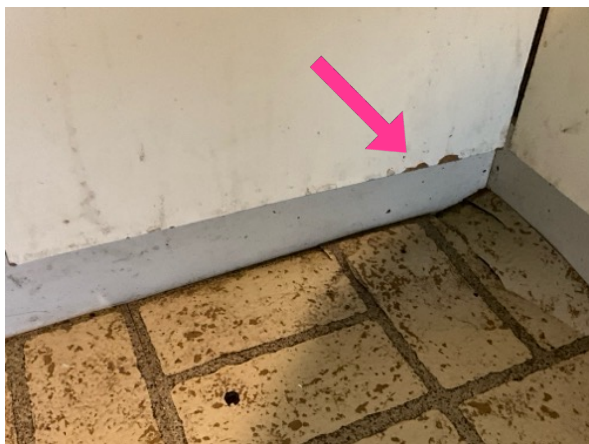
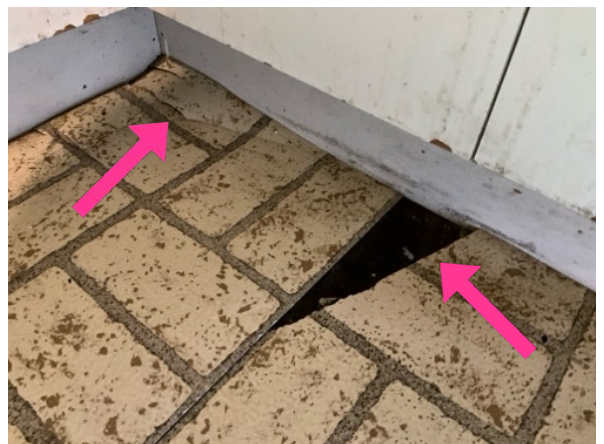
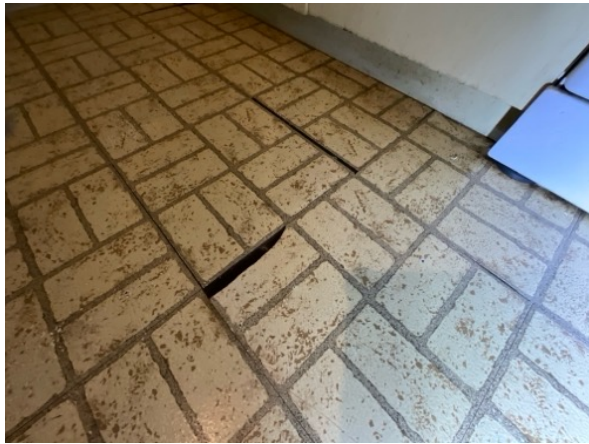
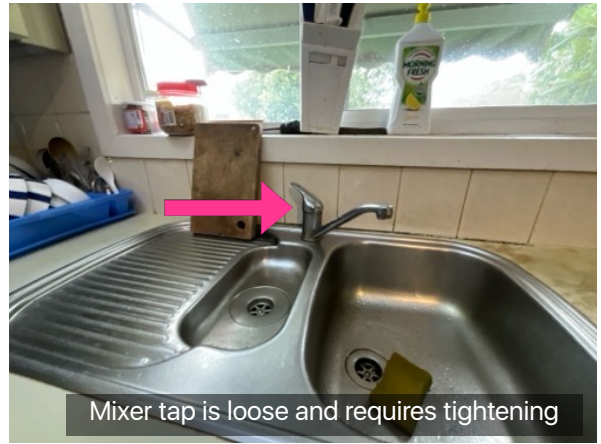
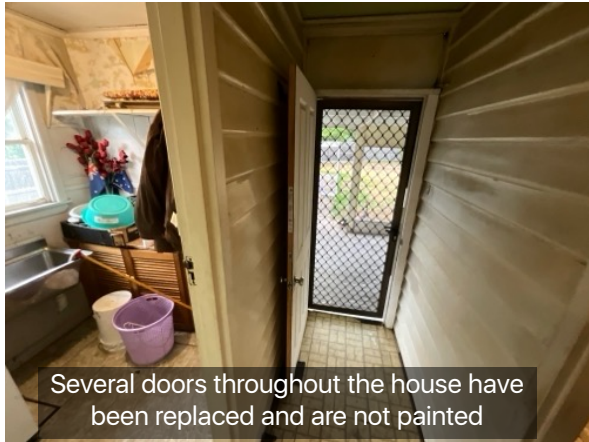
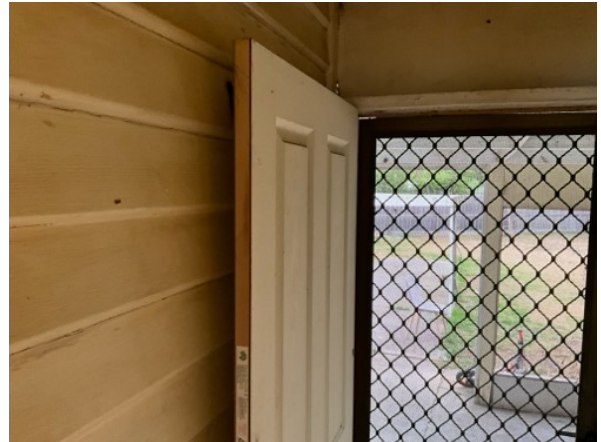
Minor Defect 3.06

Finding: Minor Defects

During the inspection of the property, it was noted that there are some minor defects present throughout the premises. The typical imperfections observed will often include cracks, surface rust, dents, and scratches in the plaster surfaces, fixtures, and fittings that are consistent with a home of this age. While these defects may be considered minor, it is important to note that they can still affect the overall condition and value of the property. The attached photos provide a visual representation of some of the defects observed, but this should not be taken as an exhaustive list. It is highly recommended that a qualified tradesperson be engaged to assess and rectify any defects that are not purely cosmetic in nature, in order to ensure the continued liveability of the home.

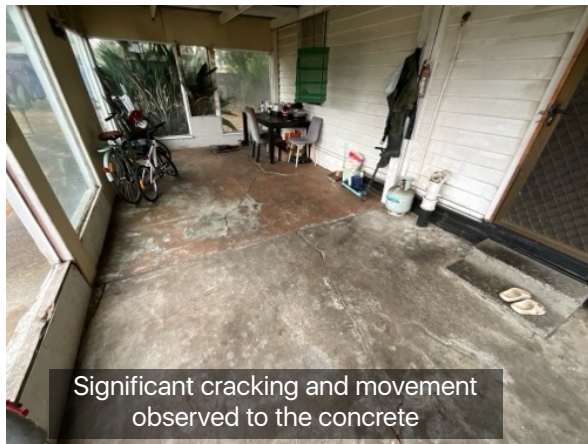
Minor Defect 3.07

Finding: Cracked concrete

Some severe cracking/deterioration was observed to sections of concrete paving. Recommend to replace where necessary as some of it has limited service life remaining, (some photo examples following). Cracking in concrete is common and is not always attributable to unsatisfactory workmanship. Common causes of cracking include shrinkage stress, stress due to trees, commercial or heavy vehicle traffic, soil movement due to changes in the moisture content as a result of garden watering or drainage problems. Tripping hazards should be filled or ground flat for the safety of the home's occupants. An investigation (by a competent person e.g. a licensed concreting contractor) is recommended to determine the method and extent of any remedial work required and associated costs.

Significant cracking and movement observed to the concrete

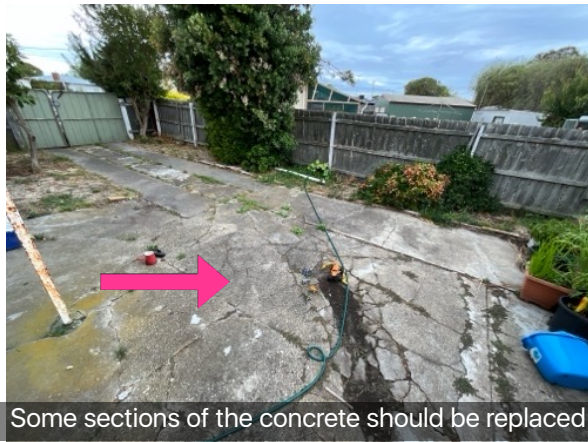
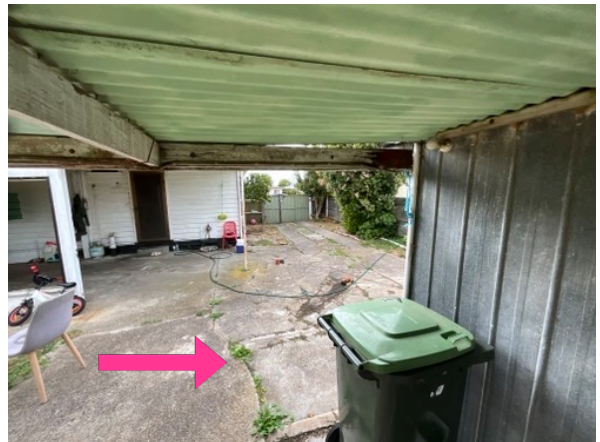
Some sections of the concrete should be replaced

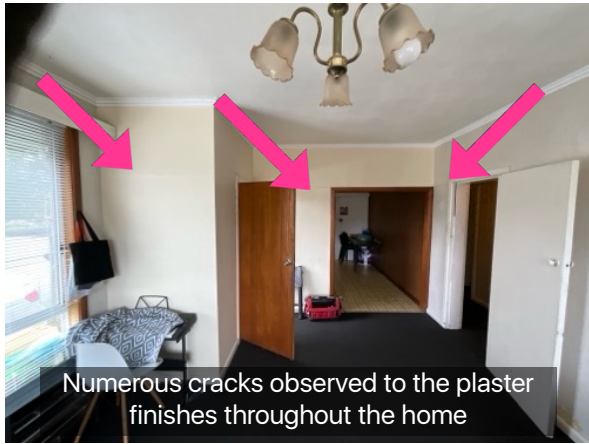
Minor Defect 3.08

Numerous cracks were observed in the plaster finishes throughout the home that do significantly detract from the aesthetics of the home. Depending on the standard of finish required it may be worthwhile replacing some of the plaster. (Some photo examples following]

The ceiling plaster in a number of rooms is in poor condition with cracking and bulging in places. (reasonably typical for the age of the home) This does not really get noticed in normal daytime conditions unless a torch is used but may be visible with night time lighting. If wanted this can be improved with plaster repairs/replacement depending on the standards of finish required.

Numerous cracks observed to the plaster finishes throughout the home

When repairing cracks it's recommended for a plasterer to apply a paper tape over the joint which then gives the repair some strength and capacity to resist cracking again.

An investigation (by a competent person e.g. a plastering contractor) is recommended to determine the method and extent of any remedial work required and associated costs.

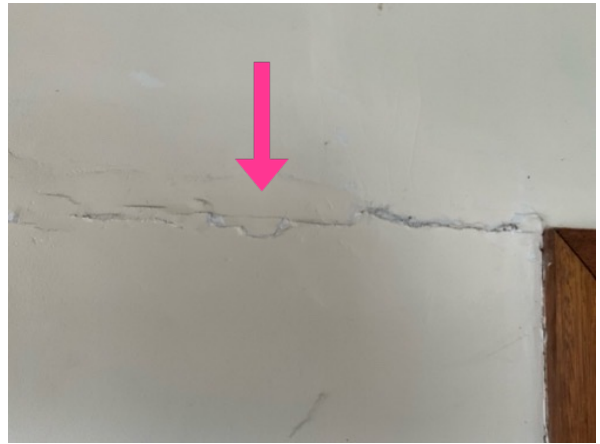
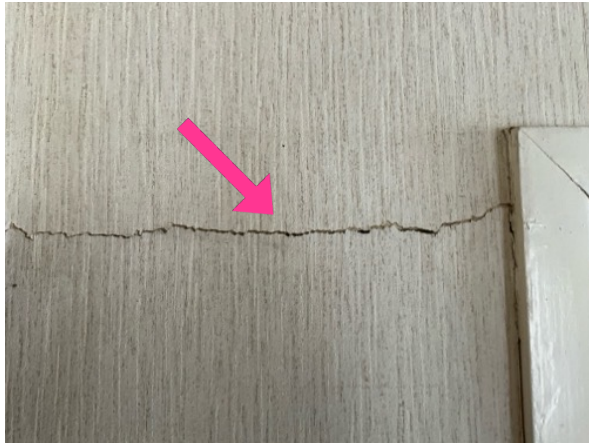
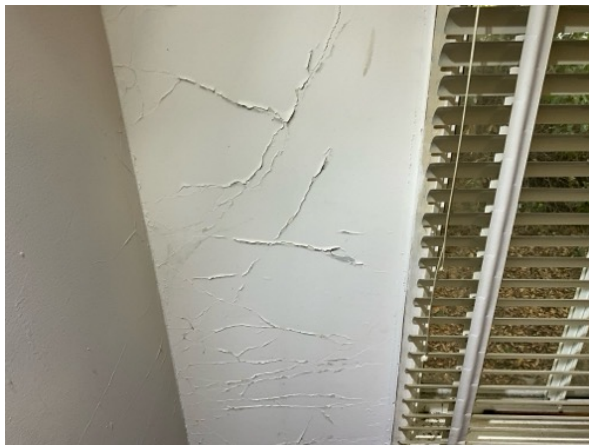
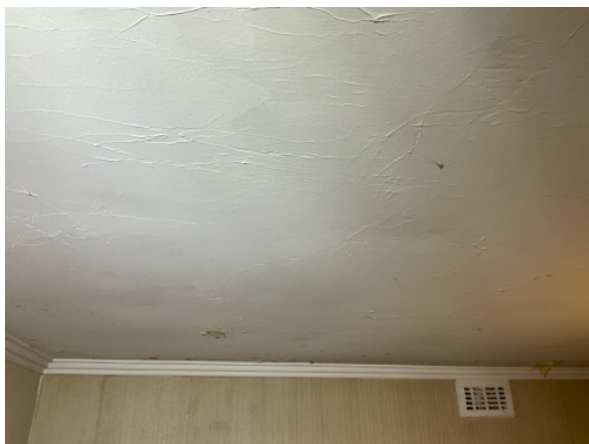
Plaster finishes have numerous cracks and deficiencies observed

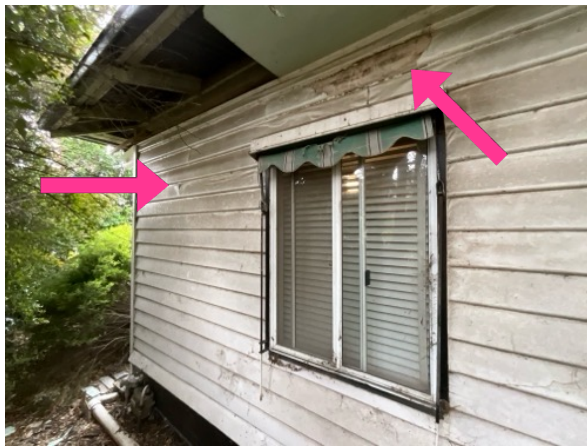
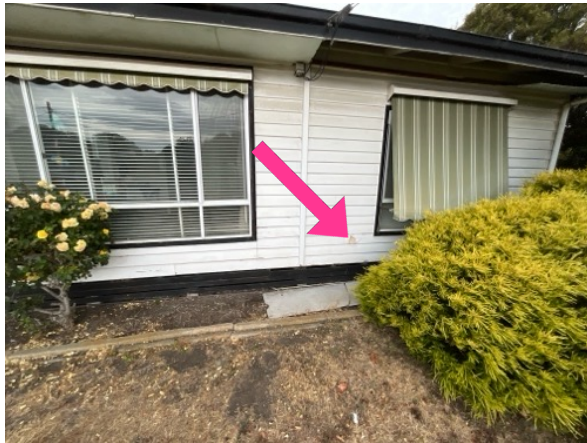
Minor Defect 3.09

Several areas of the external protective coatings [eg; paint, stains etc] have been neglected and require attention, [see photos for areas of concern]. Areas where finishes are in poor condition, potentially accelerate the deterioration of underlying building materials. Degraded finishes should be properly prepared prior to re-coating according to the manufactures instructions of the coating being utilised. An investigation (by a competent person e.g. a painting contractor) is recommended to determine the method and extent of any remedial work required and associated costs.

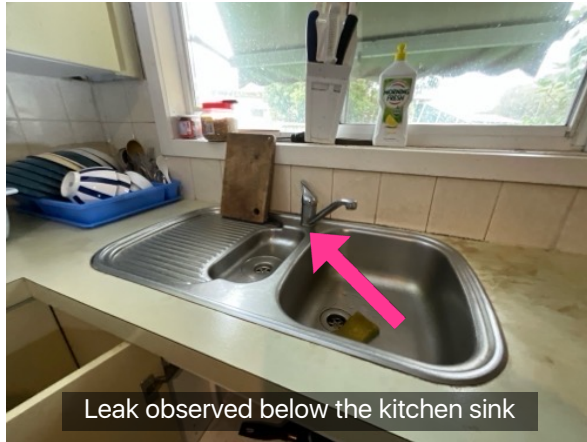
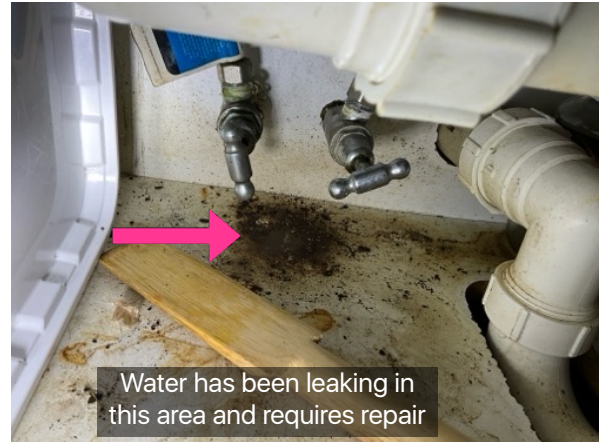
Minor Defect 3.10

Finding: Water leak/staining

In the kitchen, observable staining and deterioration have been identified beneath the sink, indicative of a water leakage likely caused by a faulty pipe connection. This issue requires immediate attention to prevent further damage and potential mold growth. It is recommended that a licensed plumber be engaged to assess the situation and undertake necessary repairs to ensure effective resolution and prevent recurrence.

Prompt remediation will help maintain the integrity of the cabinetry and associated fixtures.
