3x Sample Property and Timber Pest Reports

Property and Timber Pest Report

Inspection Date: 6 Mar 2026

Property Address: 01 Sample st Armstrong Creek

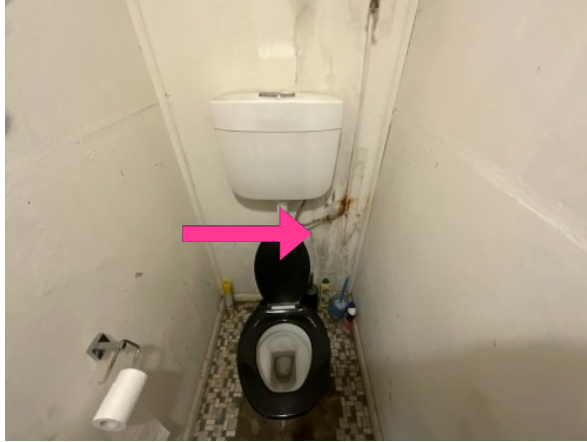
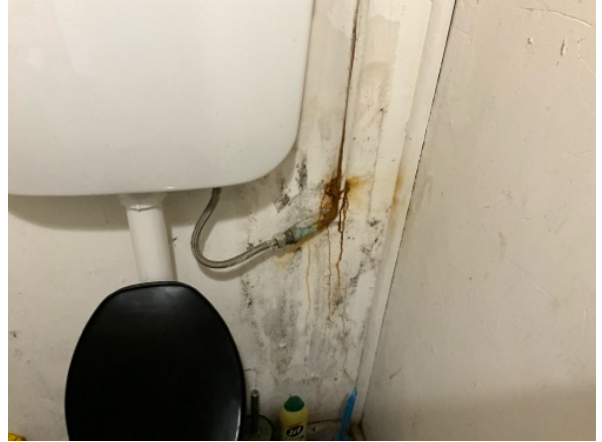
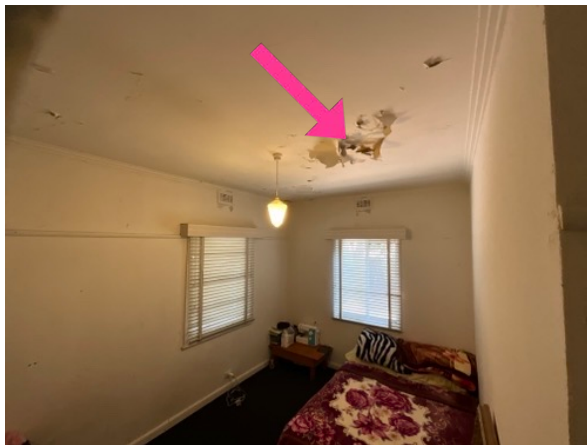
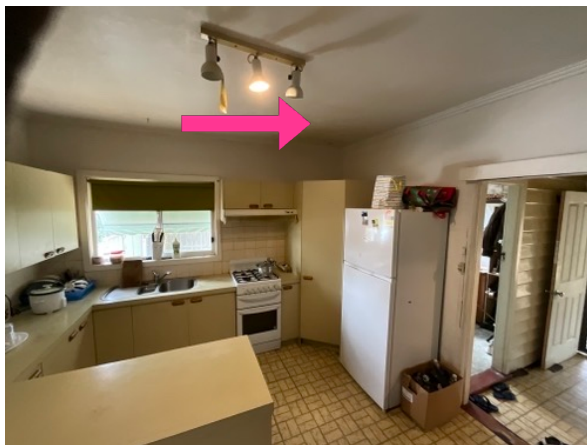
Minor Defect 3.11

Some mould was observed within the home where moisture leaks have occurred. (Some photo examples following) The cause of the moisture leaks should be repaired as soon as possible. [See separate defect statements] An investigation (by a competent person e.g. a mould specialist) is recommended to determine the method and extent of any remedial work required and associated costs.

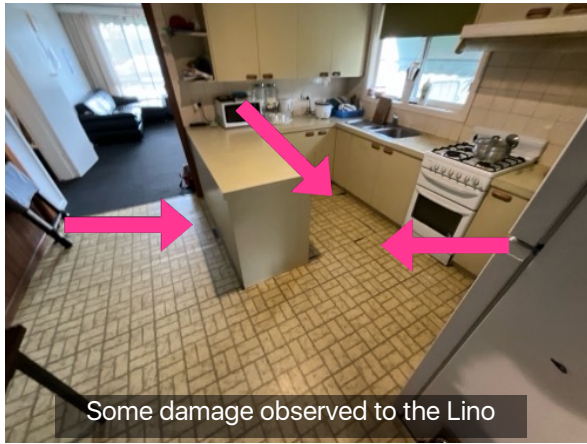
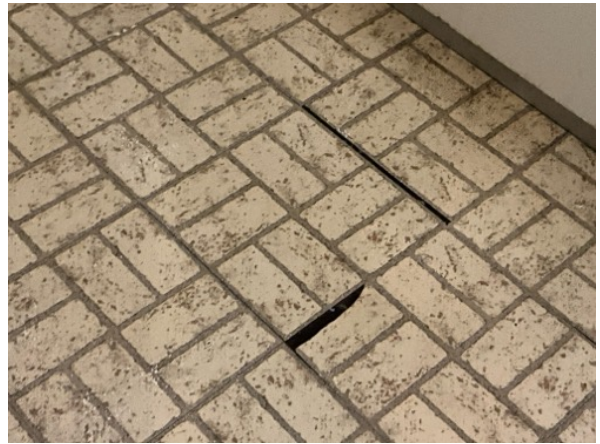
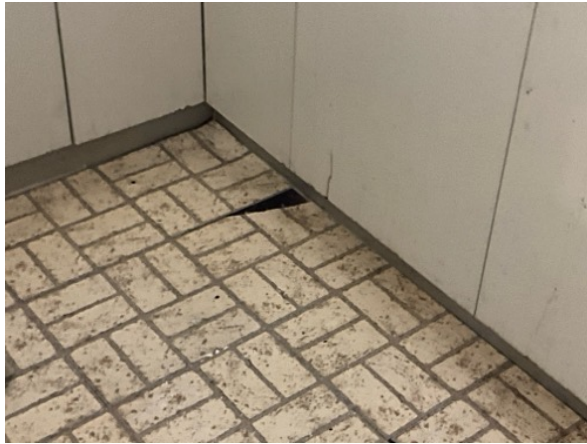
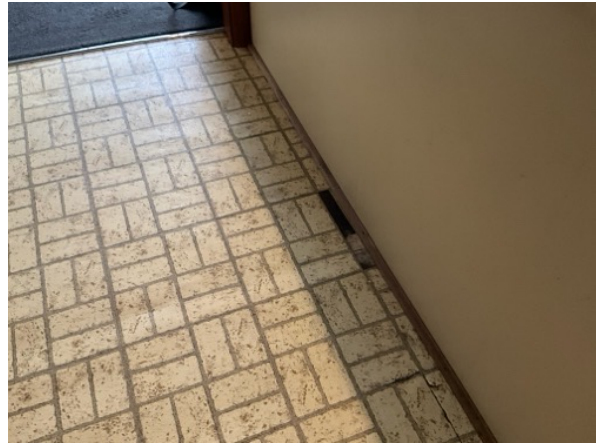
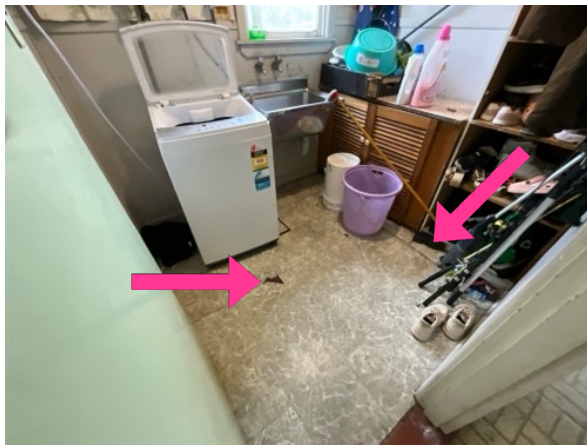
Minor Defect 3.12

Finding: Floor Coverings

Floor coverings are original with some deficiencies observed. (Some photo examples following) This could be aesthetically improved with the installation of new coverings. An investigation (by a competent person e.g. a floor covering specialist) is recommended to determine the method and extent of any remedial work required and associated costs.

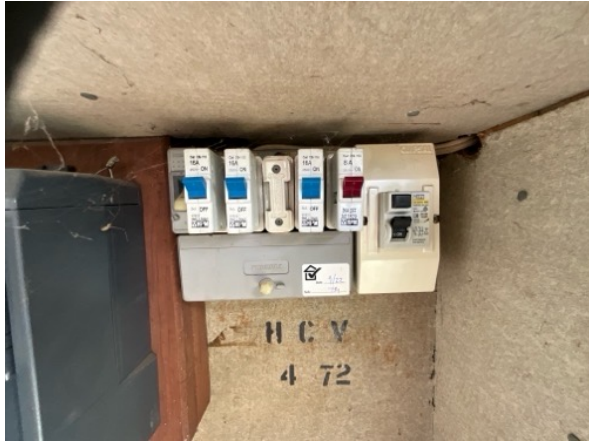
Minor Defect 3.13

Finding: Fuses

The electrical switchboard is an older style that has not been upgraded. There was a safety switch observed. Recommend that the circuit board is upgraded. An investigation by a licensed electrician is recommended to determine the method and extent of any remedial and upgrade work required and associated costs.

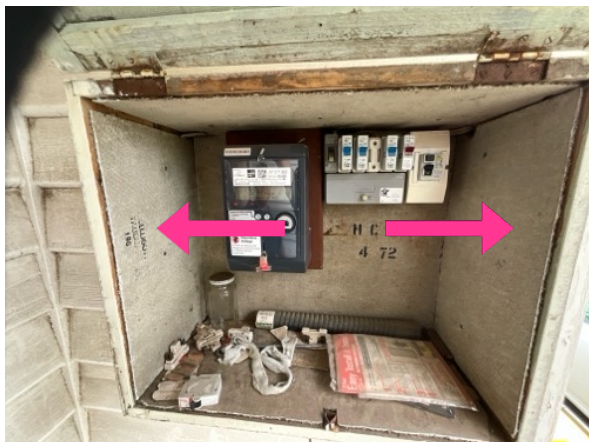
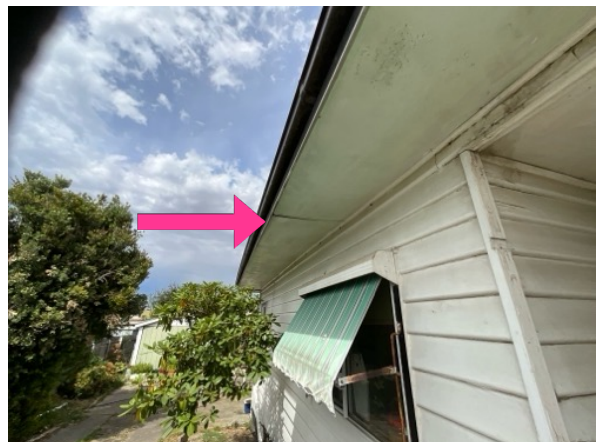
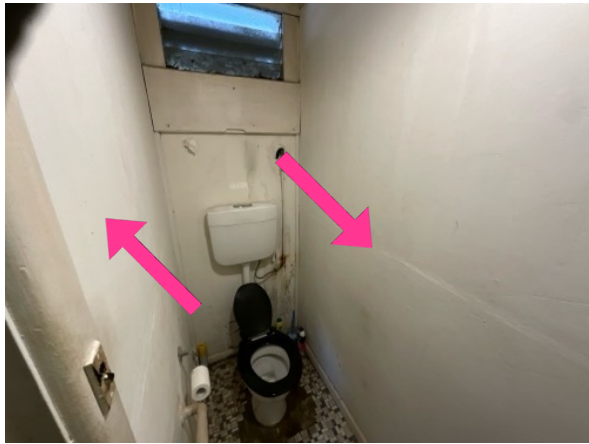
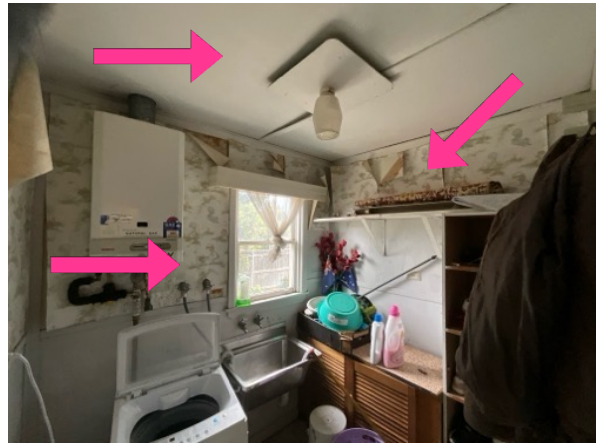
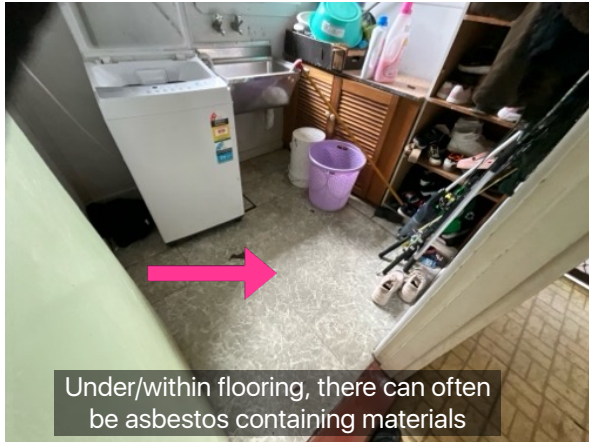
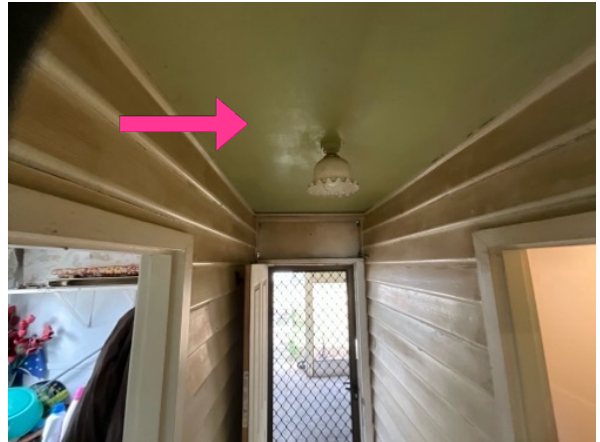
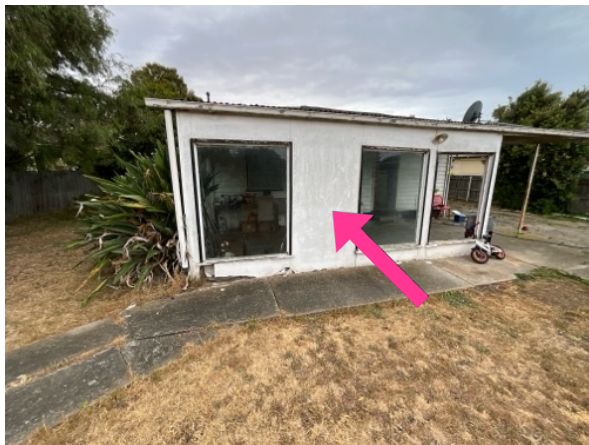
For your information 4.02

This is not an asbestos report. However I suspect, based on the age of the building and my knowledge of the building materials containing asbestos used in construction, that the following materials identified in the photos may contain asbestos. A detailed investigation by an appropriately qualified person would most likely be able to identify other materials used that contain asbestos. An investigation (by a competent person e.g. a asbestos specialist) is recommended to determine the presence of asbestos and extent of any remedial work if required.

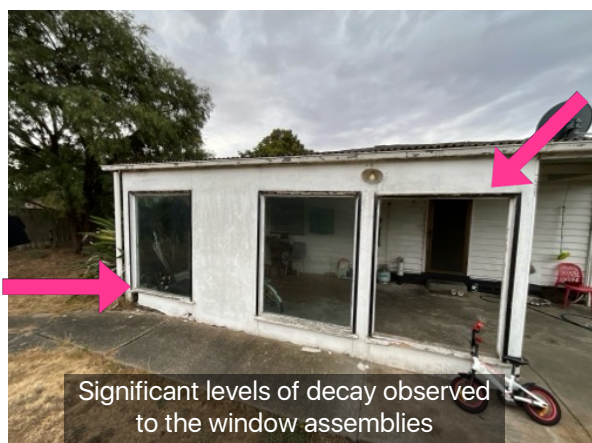
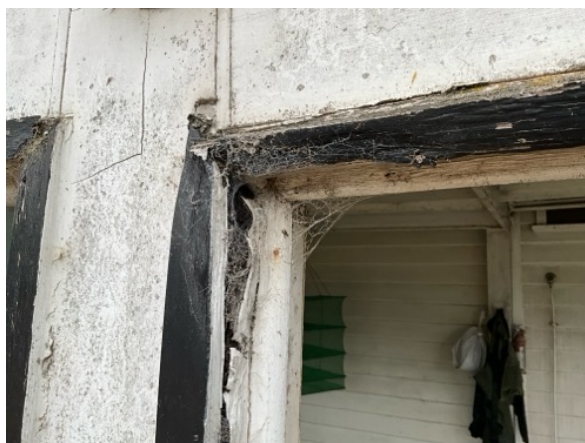
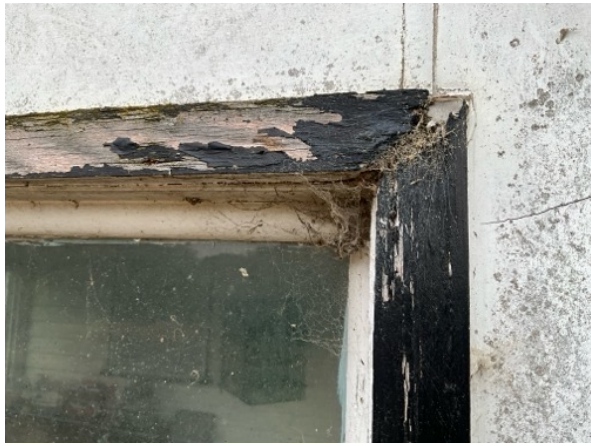
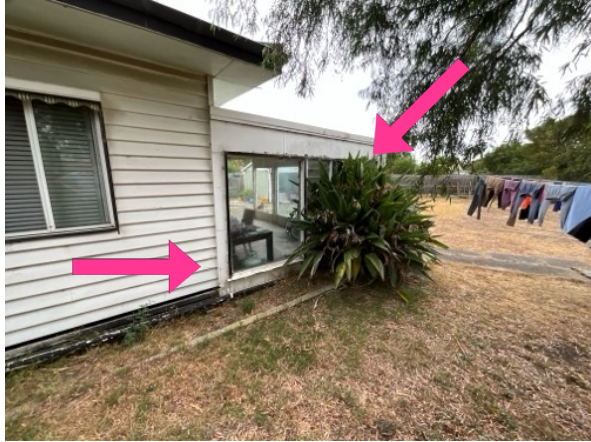
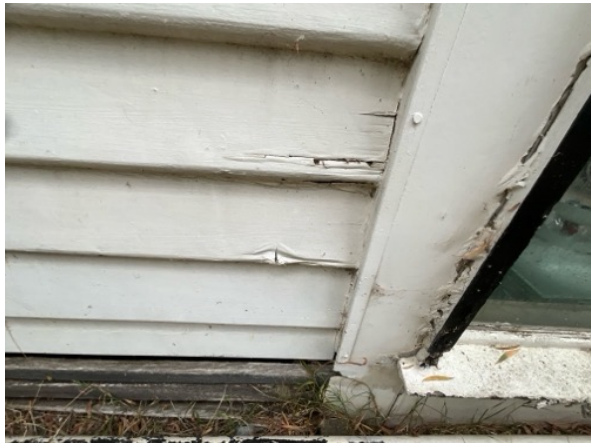
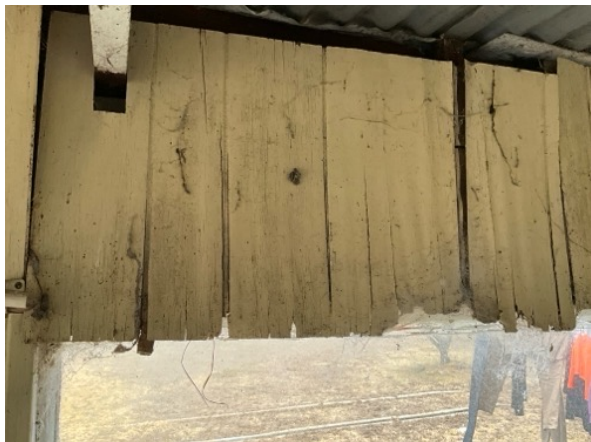
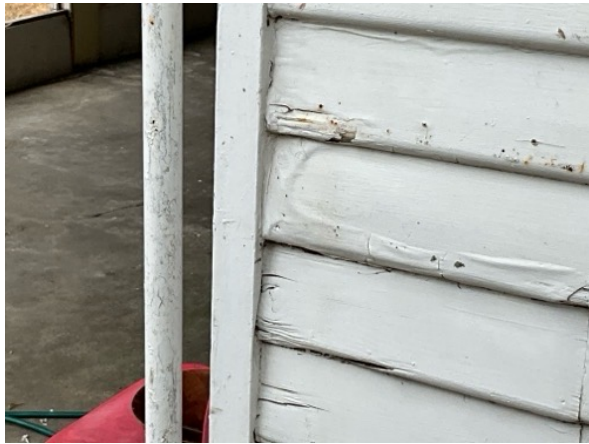
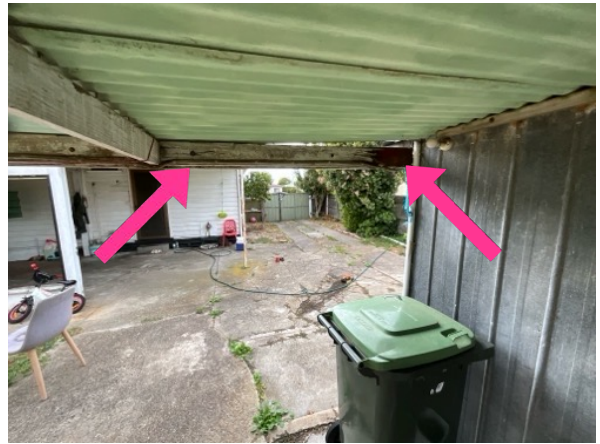
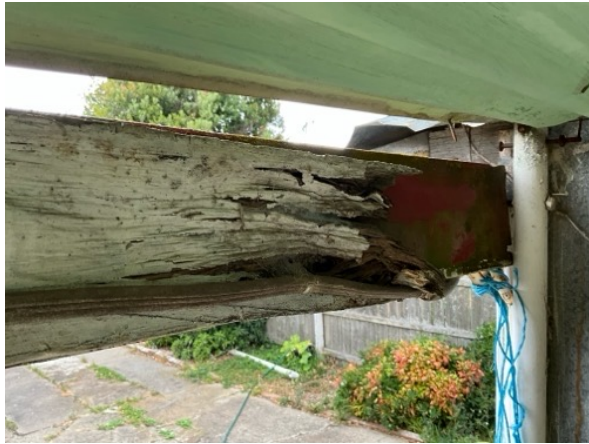
Finding: Wood rot

Exterior timber surfaces are showing signs of fungal decay in areas. (Some photo examples following) Recommend getting builder in to assess timbers and replace where necessary. A painter should then bring the paintwork back to a good standard. All timber surfaces require a regular maintenance regime as wood rot will often extend beneath painted surfaces and requires a detailed inspection (tapping) to identify.

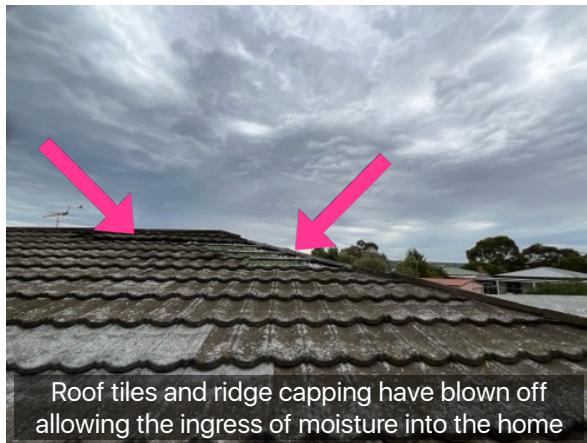
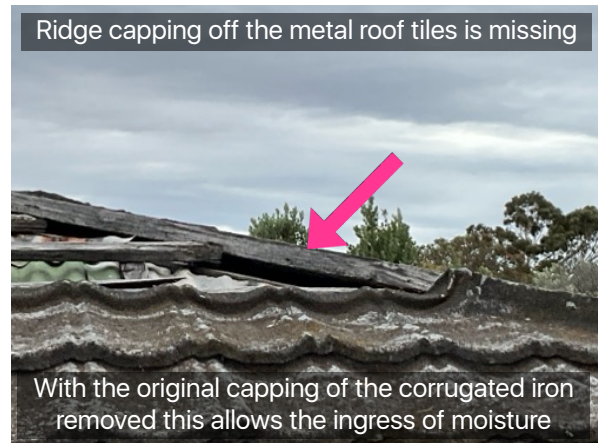
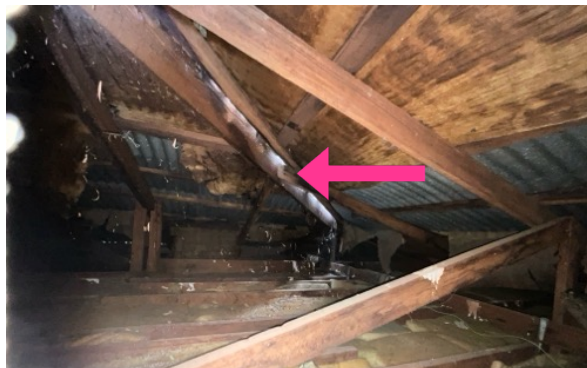
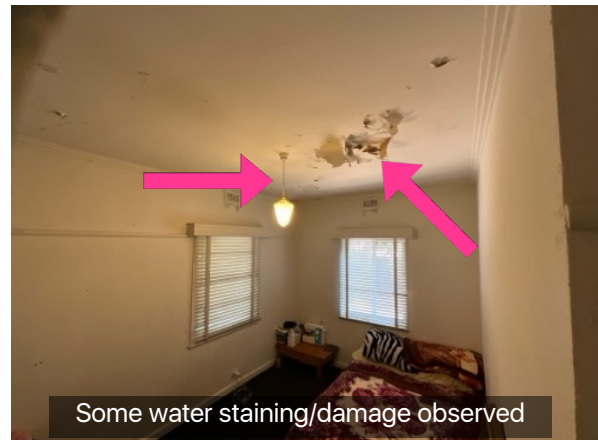
Conditions conducive to timber pest attack 5.02

Finding: MAJOR DEFECT Holes in roof tiles

The inspection of the roof exterior has revealed significant defects requiring immediate attention. The existing roof, originally constructed with corrugated iron, has been overlaid with metal roof tiles that are currently in poor condition. Numerous tiles are missing, likely due to storm damage, which has compromised the roof's integrity. The removal of the original ridge capping on the corrugated iron has further exacerbated the issue by allowing moisture ingress. The ridge capping and a number of roof tiles have blown off, resulting in visible open gaps that permit light and water into the roof cavity, as evidenced by the observed water staining and damage inside the structure. This should be repaired as soon as possible as excessive moisture can cause conditions conducive towards timber pest activity and further deterioration of internal elements. It is recommended that a qualified roofing specialist be engaged to assess the extent of the damage and determine whether partial repairs or a full replacement is advisable. Immediate remedial action is essential to prevent further water ingress and potential damage.

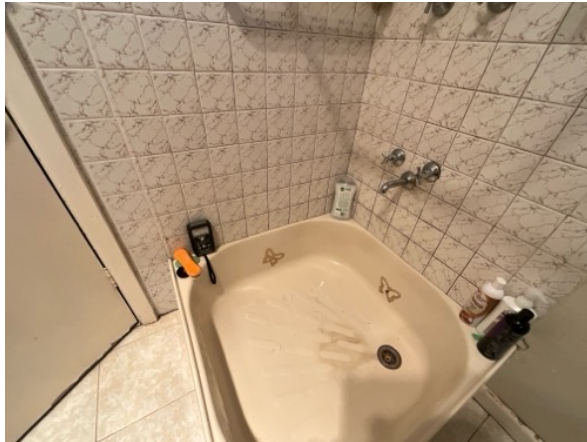
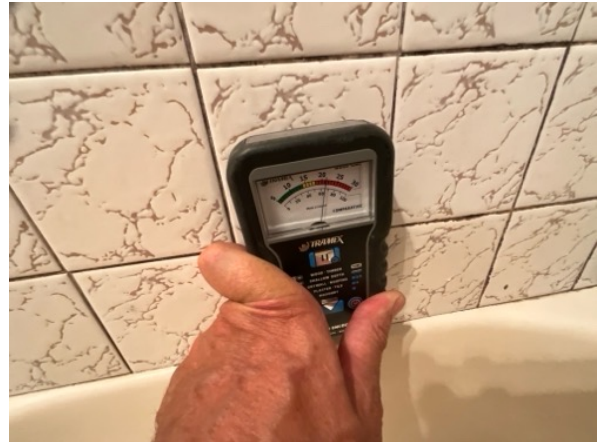
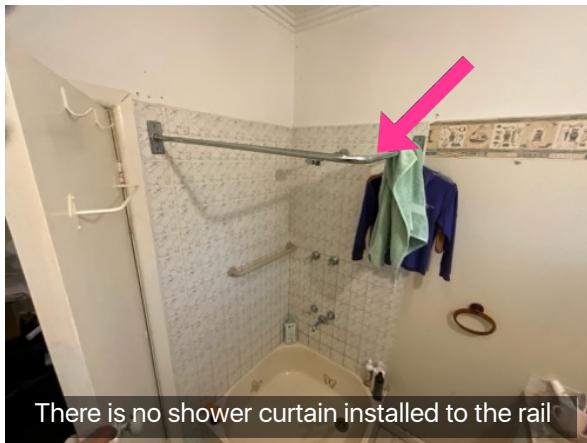
Conditions conducive to timber pest attack 5.03

Finding: Moisture in shower

There was detected high levels of moisture behind the wall tiles in the shower (see photos attached) this is indicative of moisture ingress past the outer layer of the enclosure. [See separate defect statement in building report] Excessive moisture is always concerning as it results in conditions conducive towards timber pest activity. [fungal decay, termites etc] An investigation (by a competent person e.g. a bathroom specialist) is recommended to determine the method and extent of any remedial work required and associated costs.

There is no shower curtain installed to the rail

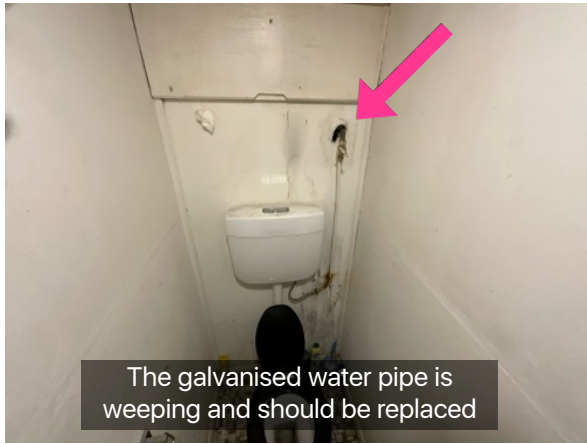
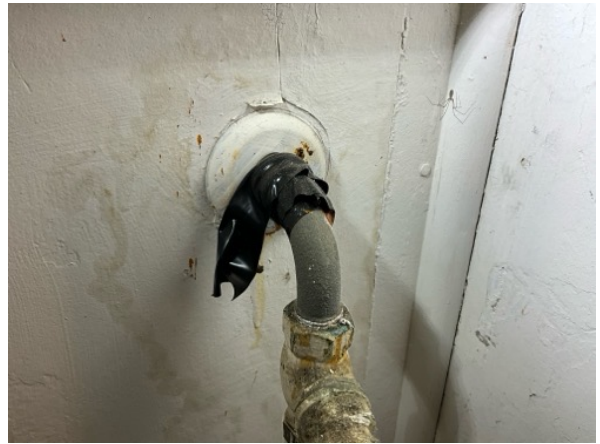
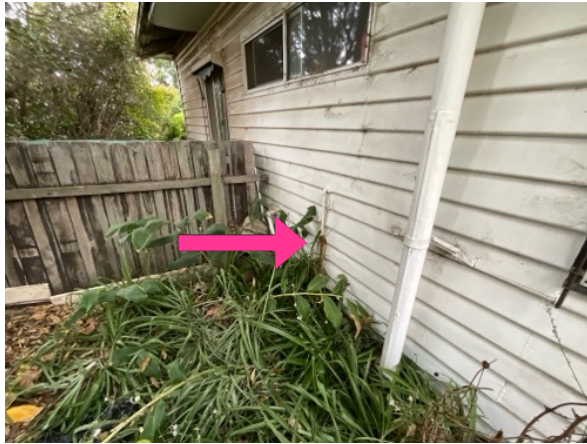
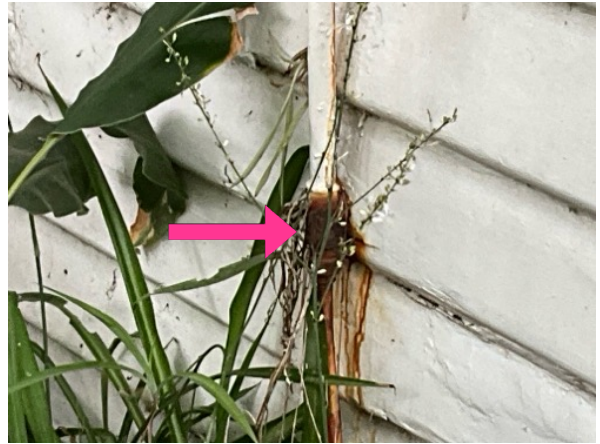
Conditions conducive to timber pest attack 5.04

Finding: Galvanised water pipe is leaking

The home has some galvanised water fittings/pipe supplying the home with some corrosion and leaks observed. This should be repaired as soon as possible as excessive moisture can cause conditions conducive towards timber pest activity and further deterioration of building elements. An investigation (by a competent person e.g. a licensed plumbing contractor) is recommended as soon as possible to determine the method and extent of any remedial work required and associated costs.

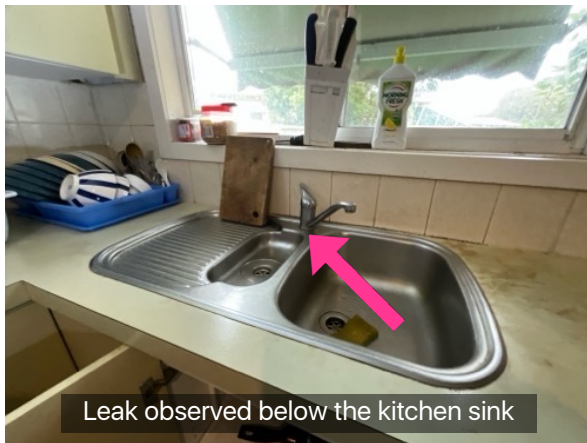
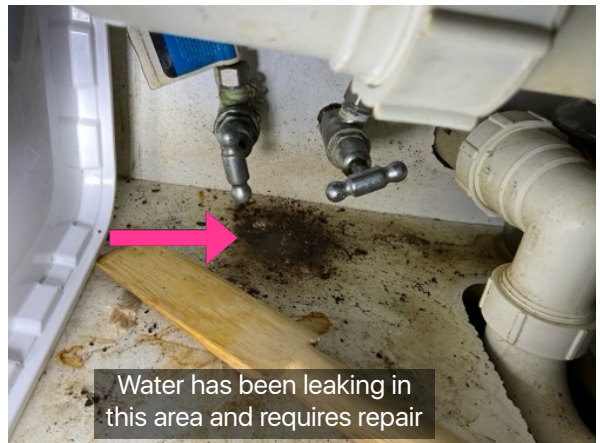
Conditions conducive to timber pest attack 5.05

Finding: Water leak/staining

In the kitchen, observable staining and deterioration have been identified beneath the sink, indicative of a water leakage likely caused by a faulty pipe connection. This issue requires immediate attention to prevent further damage and potential mold growth. It is recommended that a licensed plumber be engaged to assess the situation and undertake necessary repairs to ensure effective resolution and prevent recurrence. Prompt remediation will help maintain the integrity of the cabinetry and associated fixtures.

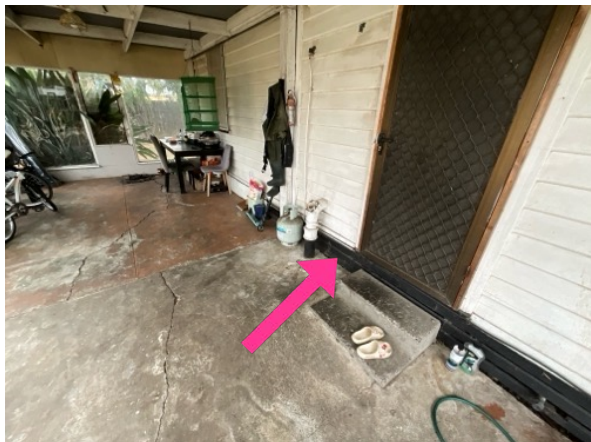
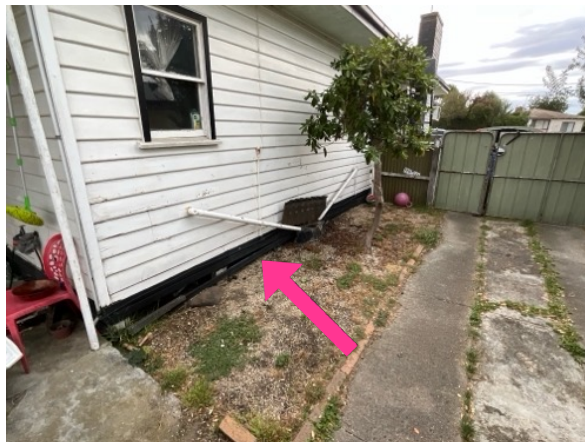
Conditions conducive to timber pest attack 5.06

Finding: Limited Access

With the limited access to the subfloor area found at this property, a thorough visual inspection was impossible to do, leaving it more at risk of a concealed termite attack. Recommend to consult with a pest technician to give strategies (baiting stations, chemical treatment etc) to help protect the residence. Below is a statement from Guide to Standards & Tolerances 2015, a publication produced by the Victorian Building Authority: "Termites are a widespread problem in all areas of Australia and it is the owner's responsibility to regularly inspect the property, including sub-floor inspections, to detect evidence of termite attack. Termites can circumvent properly executed termite protection measures, such as building tunnels around barriers. Tunnels can be identified through regular inspections and, if found, the termite nest should be located and destroyed by a suitably qualified pest controller. Termite management systems are intended to reduce the risk of damage to the structural members of buildings by deterring concealed entry of termites into a building. Termite management systems cannot prevent the entry of termites into the building."

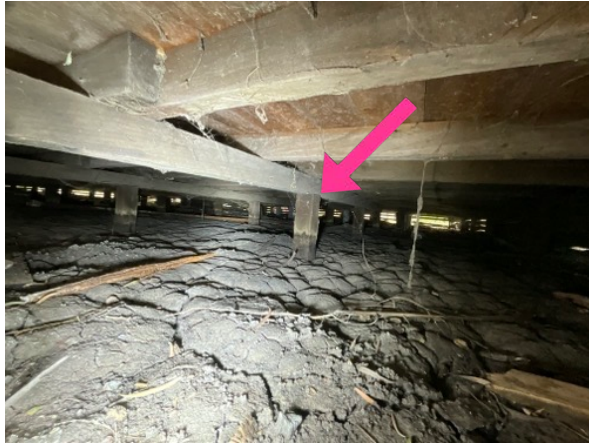
Conditions conducive to timber pest attack 5.07

Finding: No ant caps

Timber stumps have been used in the subfloor area of the home and untreated timber is in direct contact with the earth. This long term will most often result in fungal decay of the post. This also presents conditions where undetected termite attack is possible and as there are no ant caps this increases the risk of concealed attack to the home. An investigation (by a competent person e.g. a licensed re-stumping contractor) is recommended to determine the method and extent of any remedial work required and associated costs.

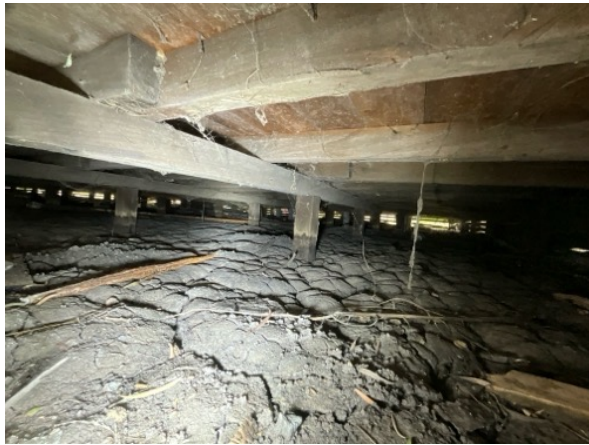
Finding: Untreated timber stumps

It was noted that the property has timber stumps. Inspection of the condition of the timber stumps - below the surface of the ground - is excluded from the scope of this report. Where timber stumps are failing, replacement of stumps may be required in the short term future. Timber stumps are no longer used in current building practices due to their susceptibility to wood rot and deterioration over time. The client should be prepared that in purchasing a property with timber stumps, that the need to restump the property in the short term future is recommended.

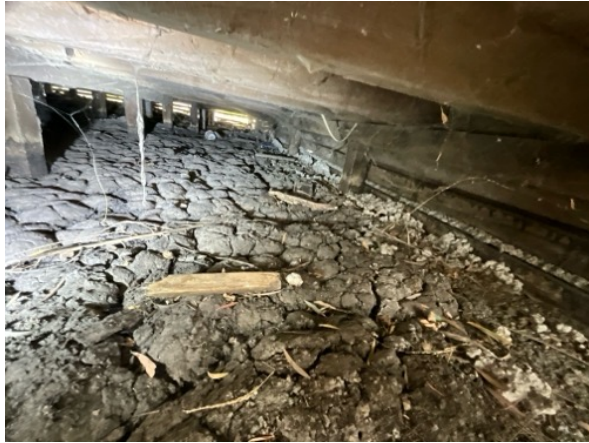
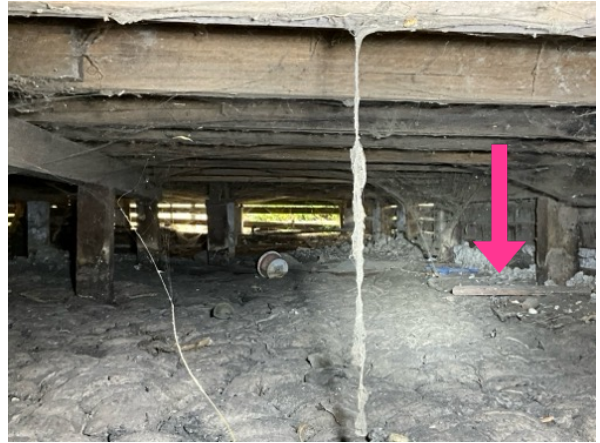
Conditions conducive to timber pest attack 5.09

Finding: Timber scraps

Debris in this area creates potential for concealed pest entry. Stored timbers and other materials may also make the area susceptible to termite activity and wood rot. A clear and empty subfloor will be better ventilated and easier to maintain in a dry condition. The removal of any timber debris is vital in minimising the risk of termite or wood borer activity. Debris in the subfloor should be removed as soon as possible.

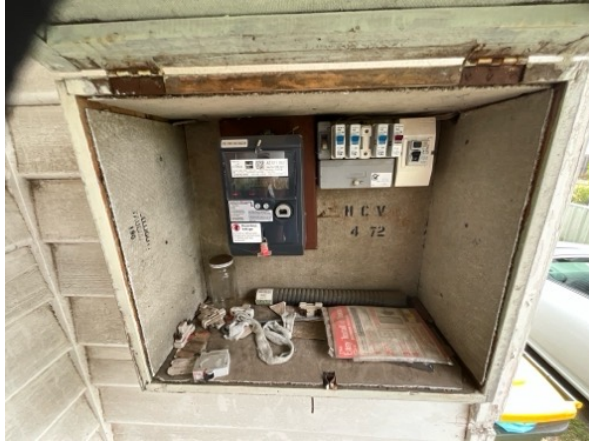
Finding: Termite Management System - no evidence of installation

A durable notice should be placed in the switchboard unit to indicate current termite barriers. At the time of inspection, it appeared as though no termite management system had been installed, with no evidence to suggest preventative works having taken place. The client may consider gaining further advice from a pest controller as to the costs and procedures involved with this application. It is recommended that obtaining such advice be a short-term priority.

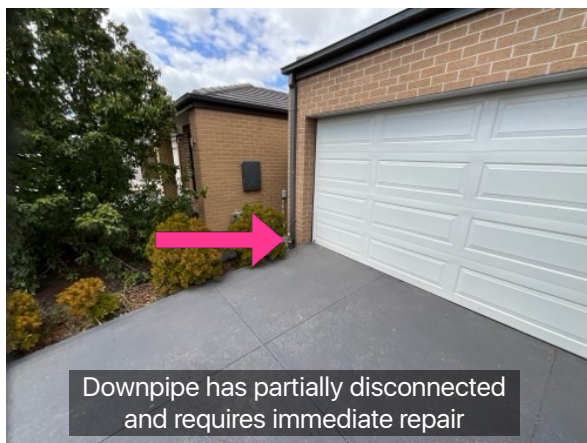
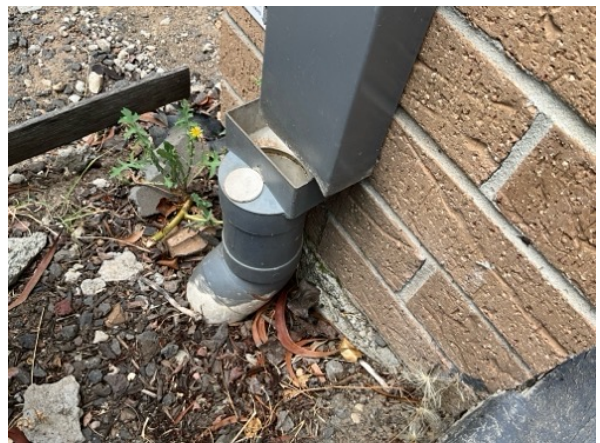
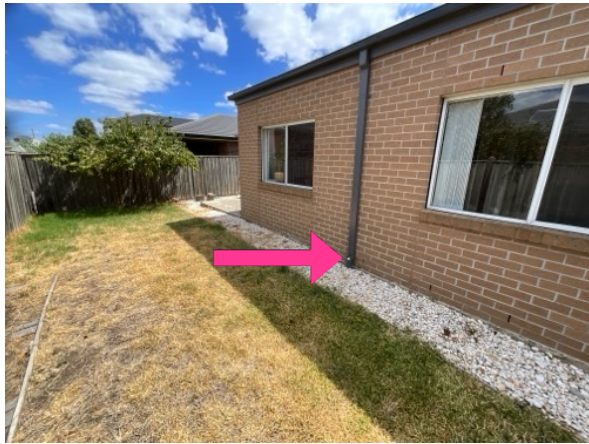
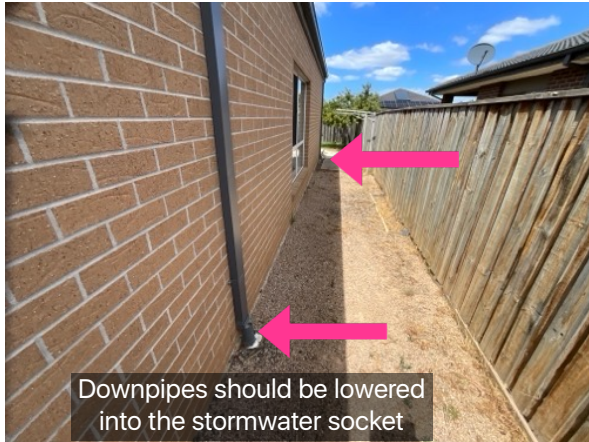
Some of the other downpipes are only just connected these should be adjusted to prevent disconnection in the future. [See photos attached for locations]

An investigation (by a competent person e.g. a licensed plumbing contractor) is recommended as soon as possible to determine the method and extent of any remedial work required and associated costs.

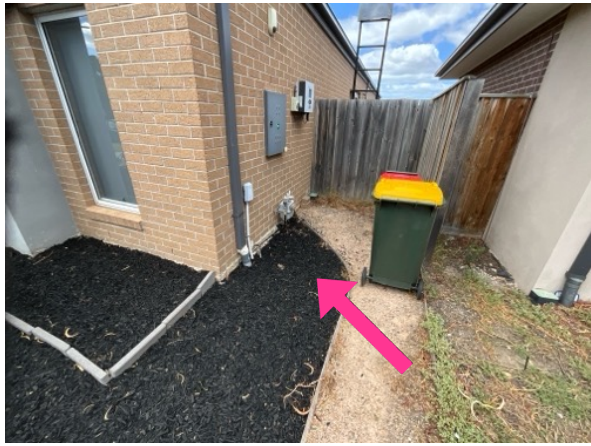
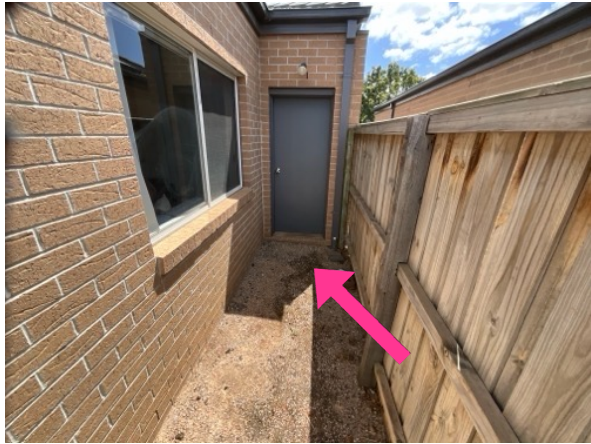
Minor Defect 1.02

Finding: Drainage

The site drainage in certain areas of the property could be improved. It is crucial to ensure that water does not accumulate against the base of walls as this can lead to foundation issues and create a favorable environment for timber pests. To mitigate these risks, it is advisable to slope the surrounding paths and ground levels adjoining the residence at a rate of 50mm per 1m to effectively drain water away from the walls. Additionally, CSIRO recommends maintaining a concrete apron measuring 1m wide around the property to help maintain footing integrity. Regular inspections after significant rainfall are recommended to identify any areas where water may be pooling or excessive moisture is present near the structure. An investigation (by a competent person e.g. a landscape contractor) is recommended to determine the method and extent of any remedial work required and associated costs.

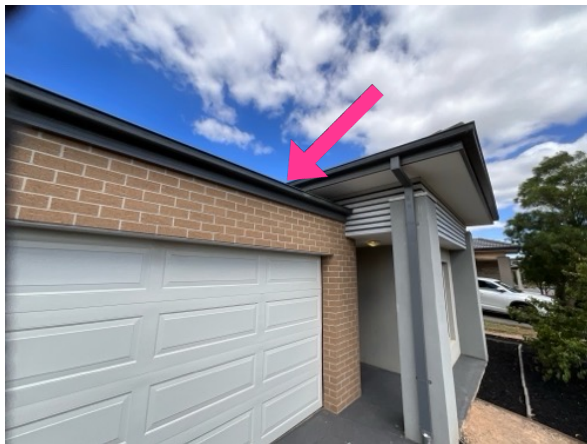
Minor Defect 1.03

BlueScope does not recommend the use of touch-up paint to repair damage or scratches to the painted surface. As explained above, air-drying paints have different weathering characteristics to COLORBOND® steel, which leads to variations in appearance over time where touch-up paint has been used. BlueScope does not have a recommended method for the removal of touch-up paint. Minor scratches (< 2mm in width) should be left alone as the available metallic coating will continue to protect against corrosion providing the scratches are superficial and the metallic coating is not damaged. If scratches are more noticeable on new material, it is the recommendation of BlueScope to replace the affected product.

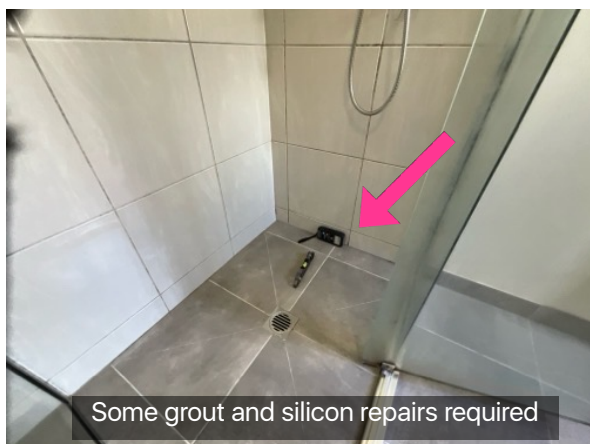
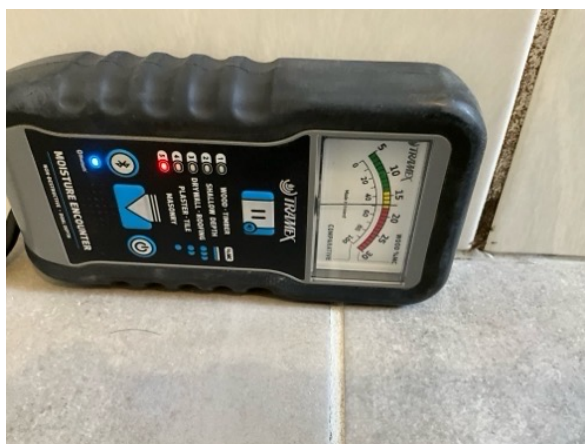
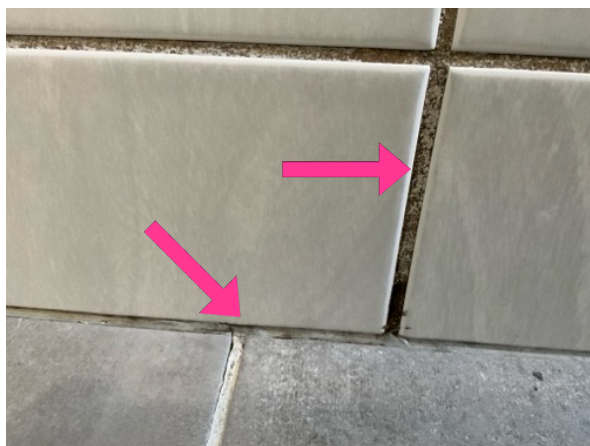
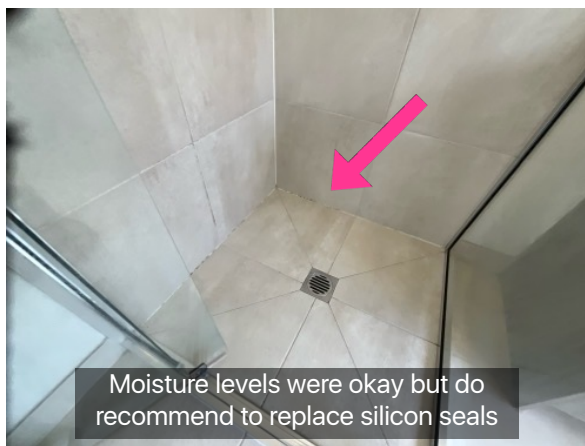
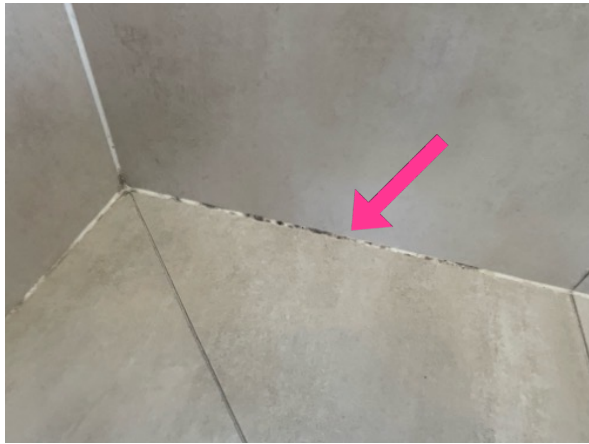
Minor Defect 1.04

The ensuite shower enclosure failed a moisture meter test which indicated moisture behind the lower wall tiles. Showers do require ongoing maintenance as grout can deteriorate over time often resulting in cracking and or pinholes to the finish of it reducing its capacity to effectively seal. Silicone should be used to seal all corner joints of tiling and where it meets baths, shower bases etc. Silicone sealants do have a limited lifespan and industry recommendations suggest it may require replacement after five years. Leaking showers can cause significant damage if left unrepaired. An investigation (by a competent person e.g. a bathroom specialist) is recommended as soon as possible to determine the method and extent of any remedial work required and associated costs.

Note: There was no evidence observed of the moisture escaping from the confines of the waterproof membrane that should have been installed.

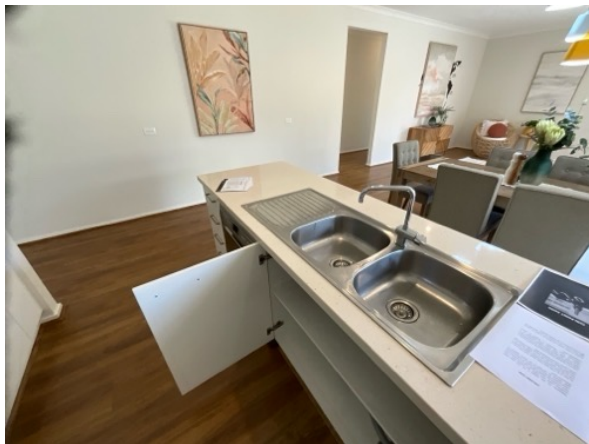
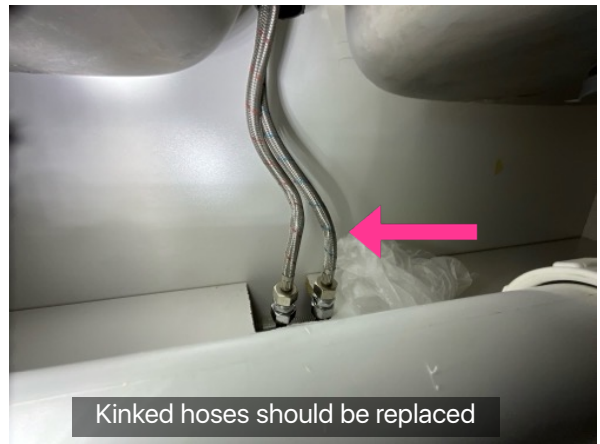
Minor Defect 1.05

According to research conducted by general insurer IAG, flexible braided hoses accounted for 22% of water damage claims in Australian households in 2016, with the claims most likely to be for kitchen and bathroom damage. IAG has even labelled flexible connectors a 'ticking time bomb' and put notices on its website advising home owners that flexible hoses have a lifespan of between five and ten years, and should be checked by a licensed plumber every two years.

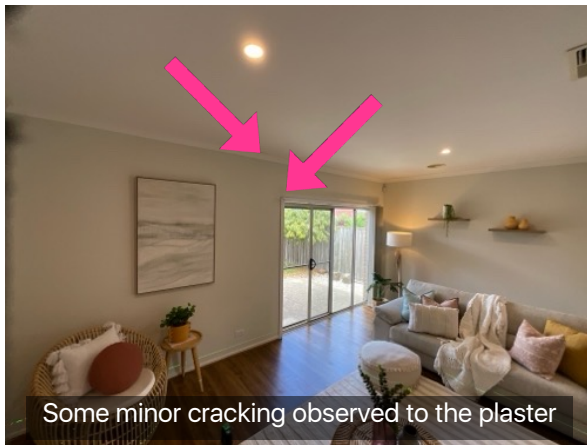
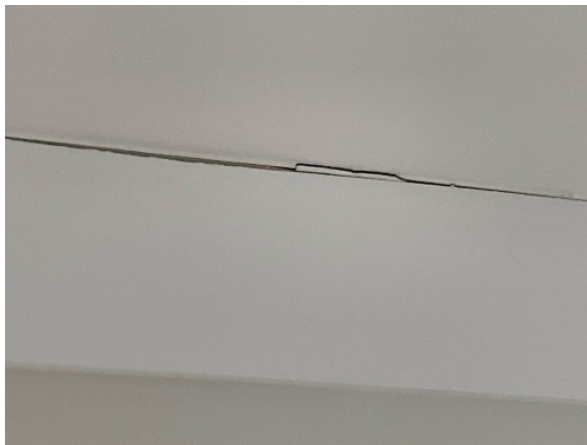
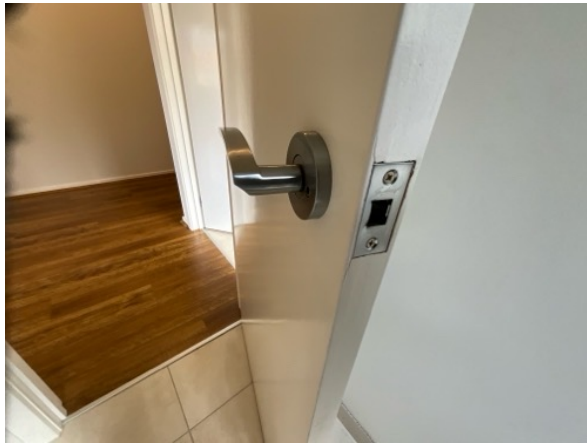
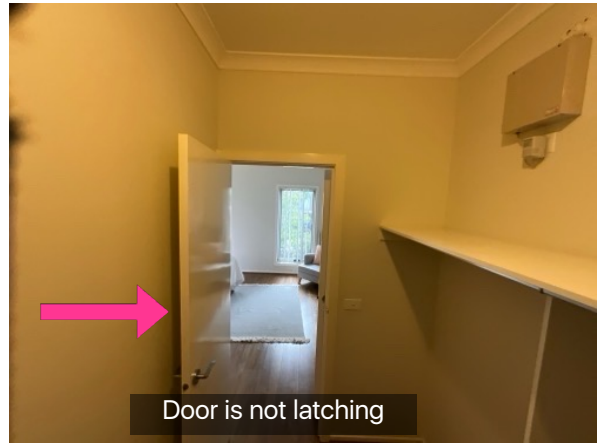
Minor Defect 1.06

Finding: Minor Defects

During the inspection of the property, it was noted that there are some minor defects present throughout the premises. The typical imperfections observed will often include cracks, surface rust, dents, and scratches in the plaster surfaces, fixtures, and fittings that are consistent with a home of this age. While these defects may be considered minor, it is important to note that they can still affect the overall condition and value of the property. The attached photos provide a visual representation of some of the defects observed, but this should not be taken as an exhaustive list. It is highly recommended that a qualified tradesperson be engaged to assess and rectify any defects that are not purely cosmetic in nature, in order to ensure the continued liveability of the home.

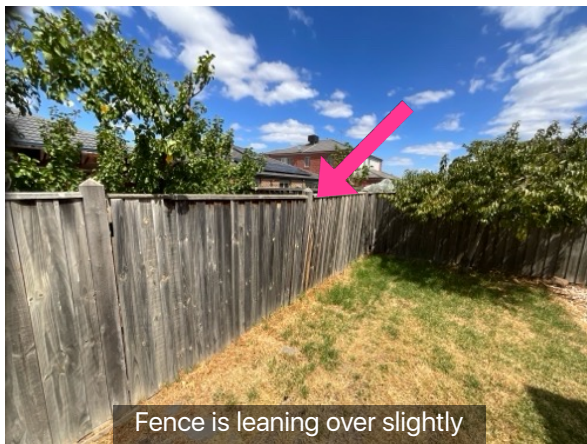
Minor Defect 1.07

Finding: Fence

All the fences were not in good order, with some requiring works to be completed. Photos of subject fences are attached with overview of defects. An investigation (by a competent person e.g. a fencing contractor) is recommended to determine the method and extent of any remedial work required and associated costs.

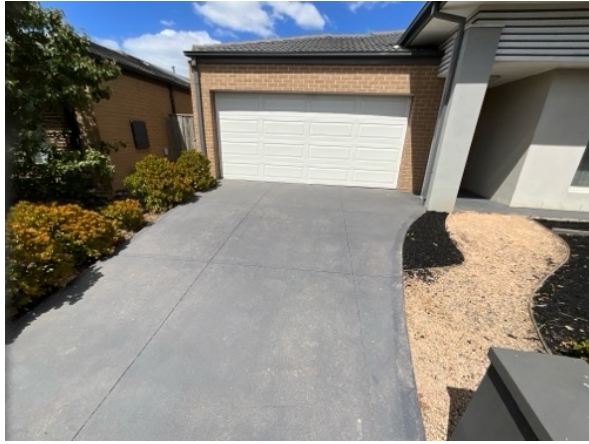
Minor Defect 1.08

Cracking was detected to sections of concrete paving. (See photos attached) This is a common issue with a large percentage of homes and can be caused by many differing factors including poor ground preparation, inadequate steel reinforcing, etc. Repairs are not considered essential unless tripping hazards present where it then recommended to grind it flat. Monitor for further changes.

Note: Cracks are not typically able to be observed in photos

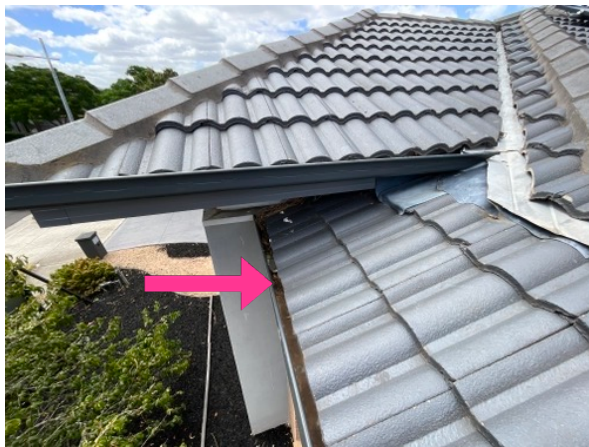
Minor Defect 1.09

Some gutters are dirty and require cleaning out. Dirty gutters will often result in a reduced service life as well as blocking the flow of water. In severe cases this can result in gutters overflowing and in some situations, especially concealed gutters, potentially impacting internal elements of the home. These gutters should be cleaned as soon as possible. Where there is vegetation on the roof this should be removed to prevent deterioration occurring to the roof sheet. An investigation (by a competent person e.g. a handyman) is recommended to determine the method and extent of any remedial work required and associated costs.

Note: The manufacturer Bluescope Steel says “Moisture or moisture retaining materials should not be permitted to remain in intimate contact with ZINCALUME® steel, COLORBOND® steel or galvanized steel. Such contact will ultimately result in corrosion of the material. The major factors influencing corrosion are the continual retention of moisture and the differential concentration of oxygen at the material surface. The accumulation of debris (leaf matter, dirt etc) which results in continual immersion, is the most common reason for unsatisfactory performance of guttering.”

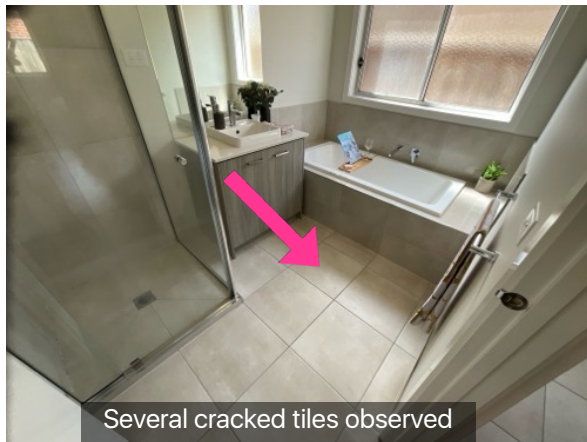
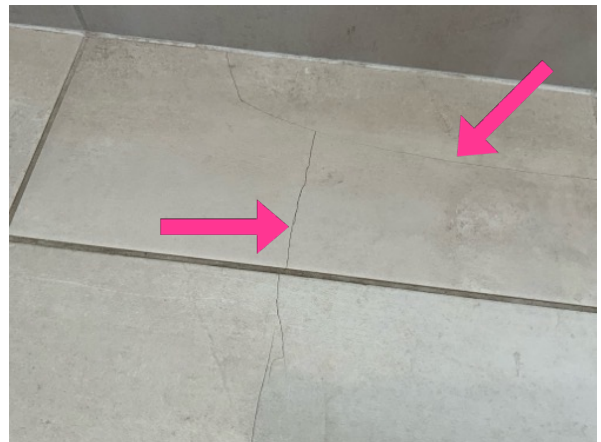
Minor Defect 1.10

There were some cracked floor tiles observed, (see attached photos for locations). There are a number of factors that can cause cracking of floor tiles some of these are localised movement of the substrate the tile is adhered to, uneven application of bedding material, etc. Should the cracking increase in the width or number, it would be recommended for further investigation to be undertaken.

Note: Replacing cracked tiles is possible, however it may be difficult to match unless there are spare tiles stored onsite.
