3x Sample Property and Timber Pest Reports

Property and Timber Pest Report

Inspection Date: 6 Mar 2026

Property Address: 01 Sample st Armstrong Creek

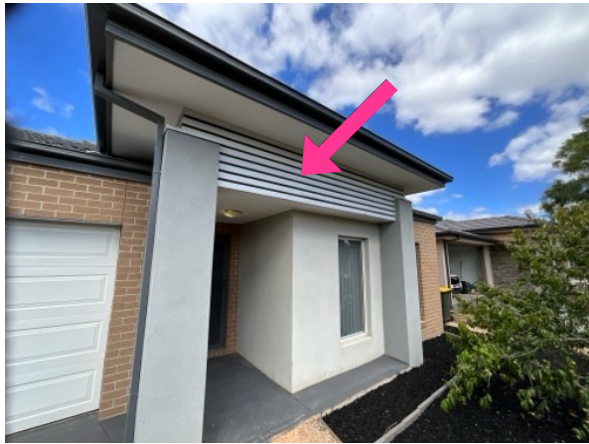
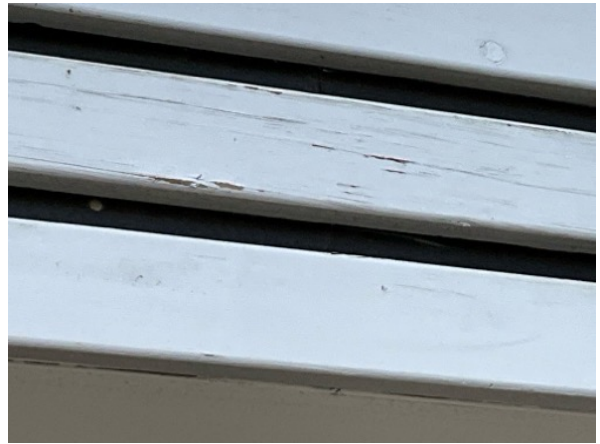
Minor Defect 1.11

Several areas of the external protective coatings [eg; paint, stains etc] have been neglected and require attention, [see photos for areas of concern]. Areas where finishes are in poor condition, potentially accelerate the deterioration of underlying building materials. Degraded finishes should be properly prepared prior to re-coating according to the manufactures instructions of the coating being utilised. An investigation (by a competent person e.g. a painting contractor) is recommended to determine the method and extent of any remedial work required and associated costs.

Note: Stains and oil coatings utilised on timber work generally require a more regular maintenance regime as they tend to deteriorate quicker than paints.

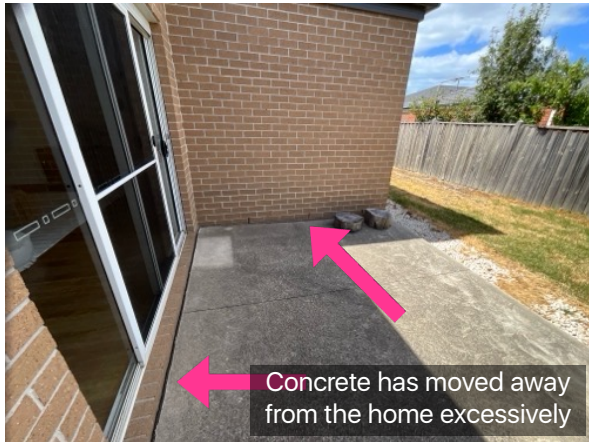
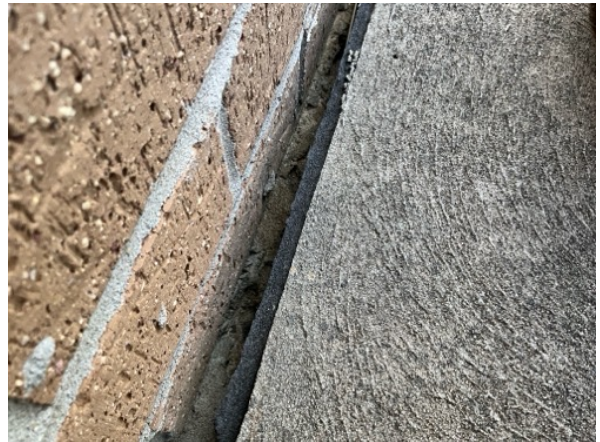
Minor Defect 1.12

Finding: Sealing up gap

The concrete paving against the home has pulled away. This is not unusual and often has happened over many years of varying ground changes. On areas where walls are exposed to driving rain it can be beneficial to seal the gap, (recommend a good polyurathane sealant), from the brickwork to the paving. This protects the foundations from excessive moisture which long term can cause foundation issues if not corrected. An investigation (by a competent person e.g. a handyman) is recommended to determine the method and extent of any remedial work required and associated costs.

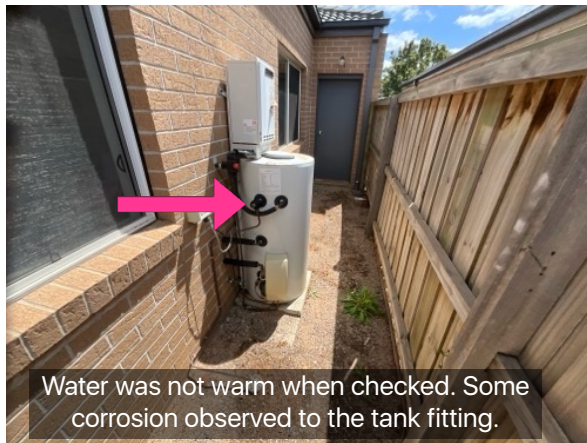
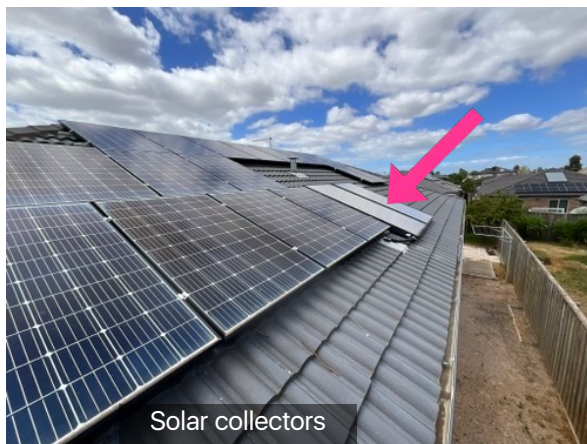
Minor Defect 1.13

Note: If the solar storage tank component is unserviceable it should be decommissioned and the instant hot water unit should still provide hot water. These solar boosted storage tanks in the past have not had a great service life and may not be worthwhile to replace it.

An investigation (by a competent person e.g. a licensed plumbing contractor) is recommended to determine the method and extent of any remedial work required, and associated costs.

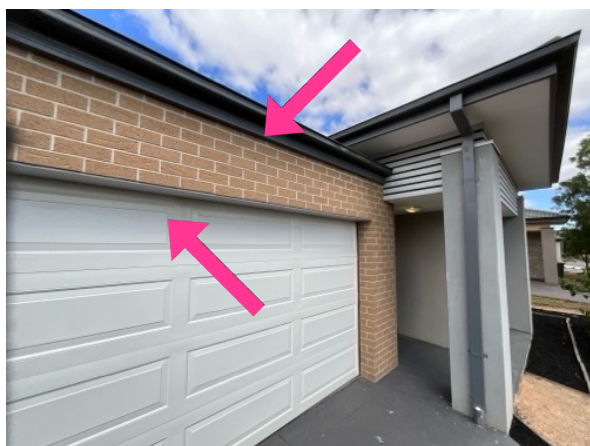
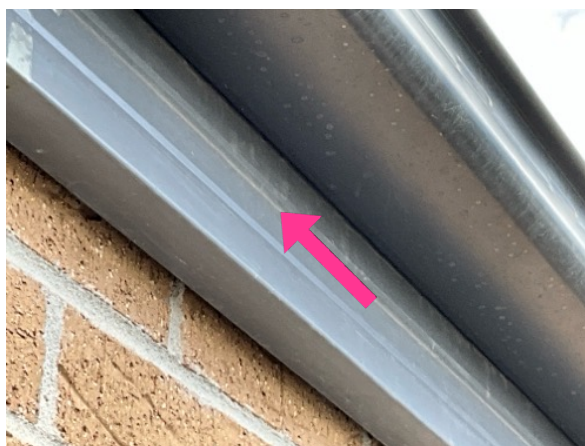
Finding: Wash down

Colourbond steel and other metal products (eg; garage door, light fittings etc) on the exterior of the house that are not washed by rainfall (covered by eaves etc) are susceptible to accelerated surface corrosion especially where a house is within proximity of a coastal environment. It is important that a regular washing down of these metal components occurs. This is a cautionary note for preventative maintenance.

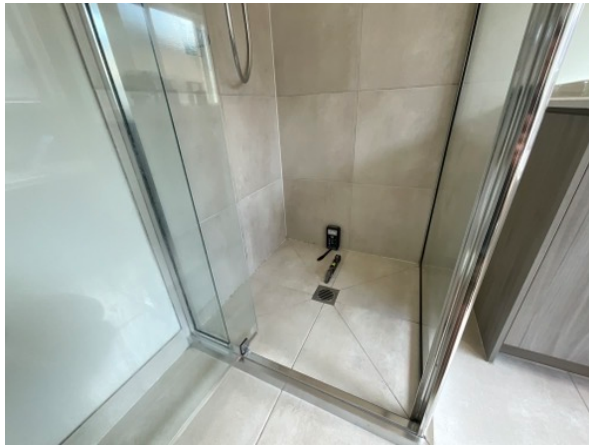
For your information 2.02

Finding: Moisture meter

When using a Tramex moisture meter within the shower enclosure, the readings were considered to be within the acceptable range.

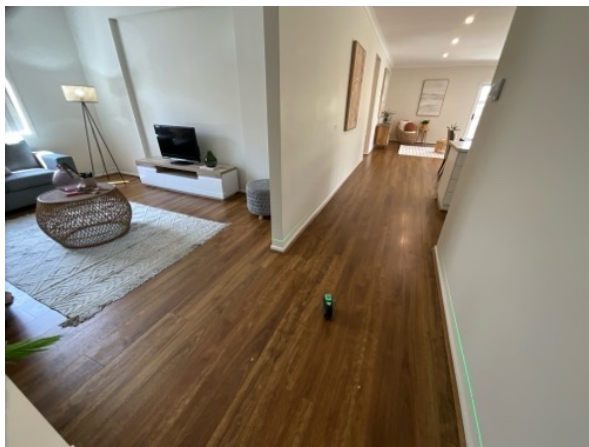
For your information 2.03

Finding: Laser level

A laser level was used to check the floor levels throughout the home. Only minor variations were observed and considered to be within acceptable tolerances.

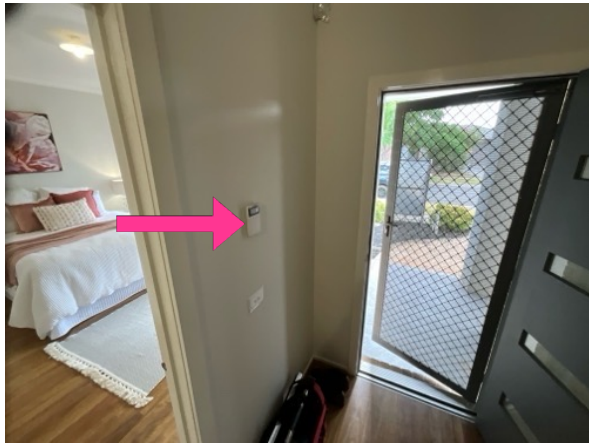
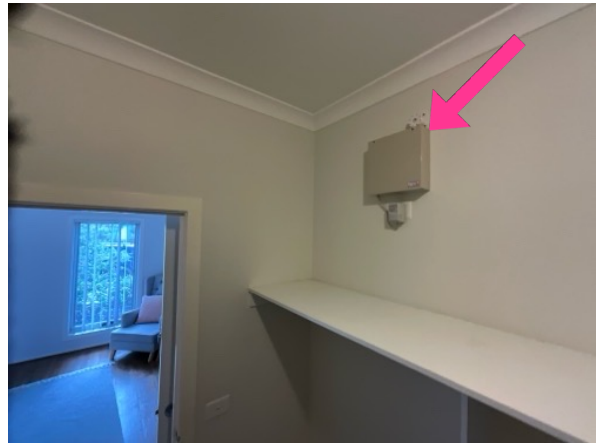
For your information 2.05

An alarm system was observed onsite. These are not touched or checked during inspections due to the inherent concerns with setting off alarms. It would be recommend to review all paperwork available for the system and have the current owners or alarm specialist go through the operation of the unit.

Note: The operation or serviceability of the unit is unknown.

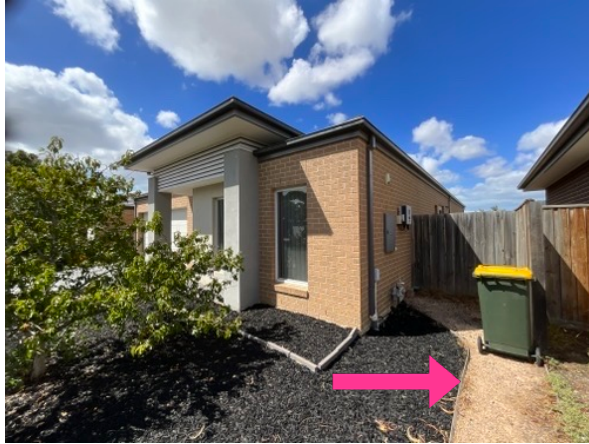
Conditions conducive to timber pest attack 3.01

Unless timber is treated or considered naturally durable, when it's in earth contact it will tend to deteriorate and be susceptible to fungal decay. This also creates conditions conducive towards termite activity. Some of the materials commonly observed includes sleepers, garden edging, fence posts, wood chips, old tree stumps

etc Recommend to minimise food sources for termites by removing areas of concern.
(See photos attached)
